FINAL REPORT:

Agnes Water and Seventeen Seventy Shoreline Erosion Management Plan (SEMP)

April 2020

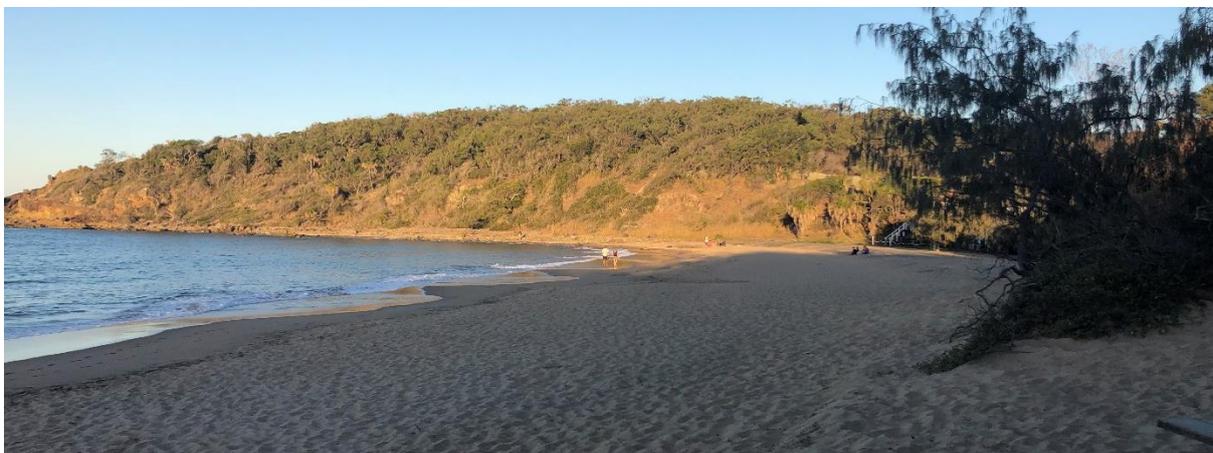
The southern most section of Agnes Water Main Beach is a Caravan Park and the current mouth of a small coastal creek/lagoon. In front of the caravan park there is evidence of the tide reaching almost up to creek water levels at the time of inspection. Efforts at dune protection and management in the form of palm fronds and branches are being undertaken, as well as signage to deter thoroughfare over the dunes (informal access). This creek entrance relies on natural opening through high creek outflows, and though it was closed during inspection, there was evidence that it had been recently open. Intermittently closed and open lakes and lagoons (ICOLLS) are natural features in the coastal environment, and regularly alter the position of the creek mouth during high flow events.

Figure 20. *Agnes Water main beach looking towards most southern end*

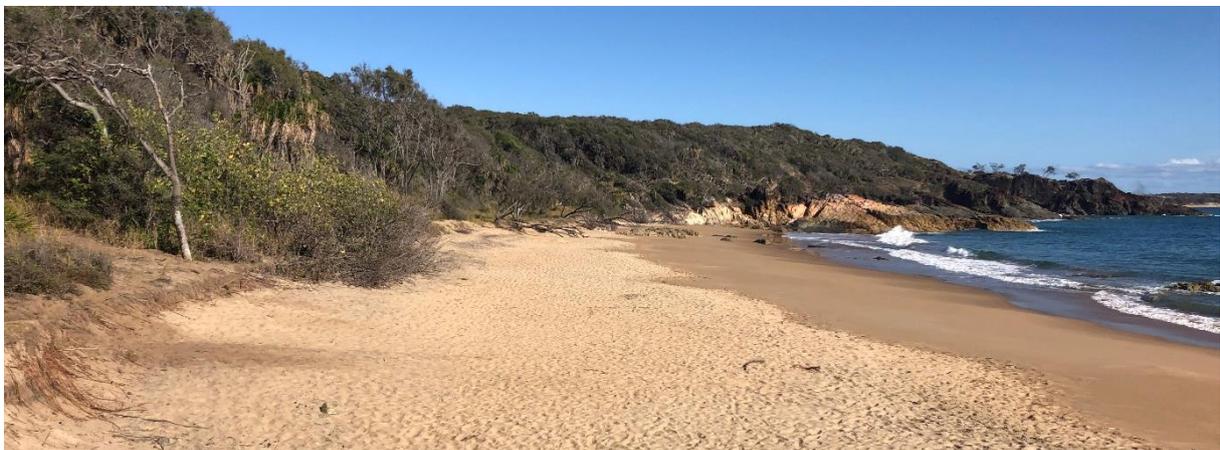
Workman's Beach (Figure 21) is a pocket beach that is confined by headlands to the north and south and is relatively protected from the offshore coastal processes. The beach has a relatively flat profile with a gentle slope, and is backed by a vegetated slope and a cliff that is 30 to 40 m high. An erosion scarp runs along the length of the beach varying in elevation, approximately 0.2 - 0.3 m in northern end, and 1 to 2 m towards the southern end. Rocky material, up to 10-15 cm diameter, is eroding from sections of the escarpment.

Figure 21. *Workman's Beach south of Agnes Water looking north*

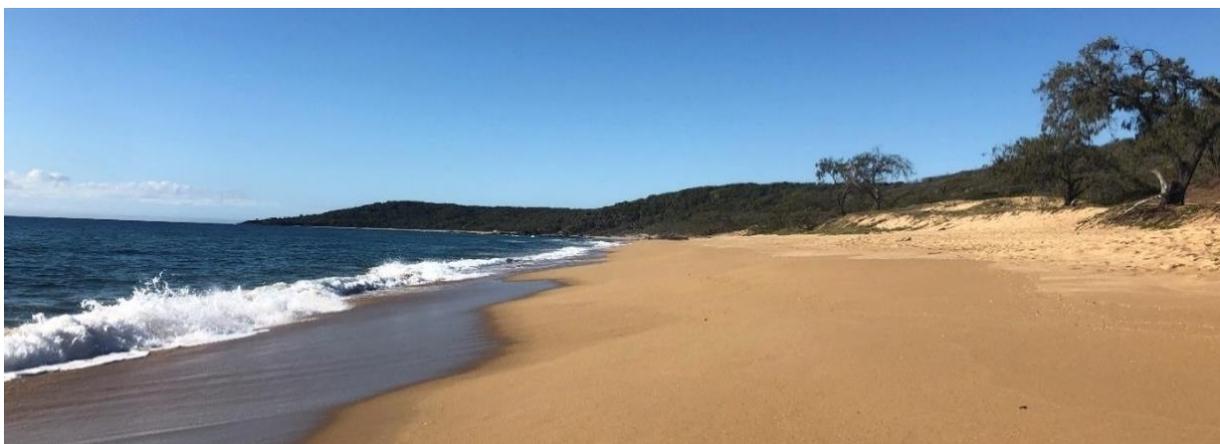
Chinamans Beach is fairly exposed to open coast processes, with steep beach profile resulting from a high energy wave climate. There is a headland to the northern extent of this beach. Chinamans Beach is backed by an approximately 200 m wide sloping vegetated dune. A desalination outfall and pump station are situated at this beach, along with an access road and small carpark. Geofabric bags have been used to limit scouring and protect some of the desalination infrastructure, with some bags currently exposed due to loss of sand.

Figure 22. *Chinamans Beach at Agnes Water looking south*

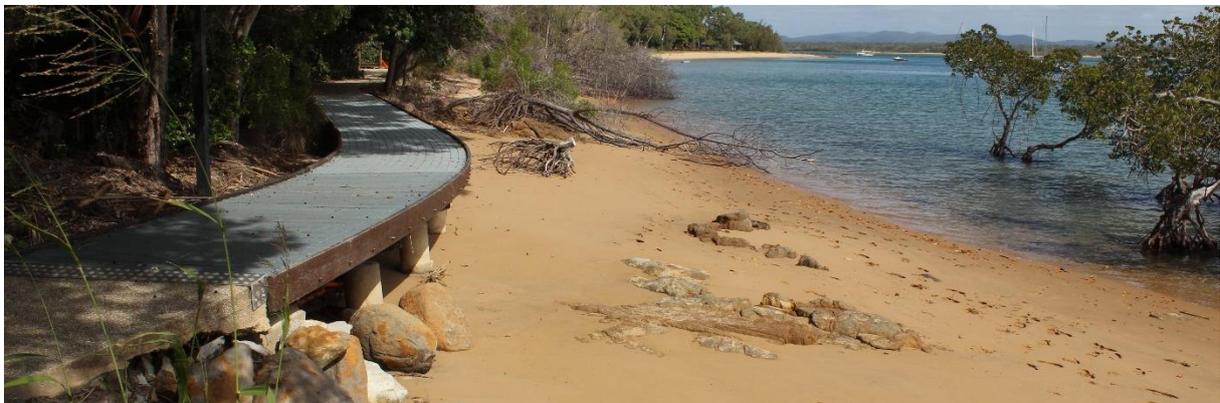
Part of the boardwalk (Figure 26) is currently closed due to safety as the foundations have become exposed and a small section has collapsed as a result of scour. Building rubble and rocks have been placed in an effort to armour the erosion scarp and boardwalk foundations.

Figure 26. Seventeen Seventy boardwalk between Endeavor Park and Seventeen Seventy township, facing south west

In adapting to this change, the boardwalk could be relocated and/or upgraded during current repairs to exist as a 'wet' feature that can withstand frequent tidal inundation of the foundations, and potentially provide a boardwalk over water experience.

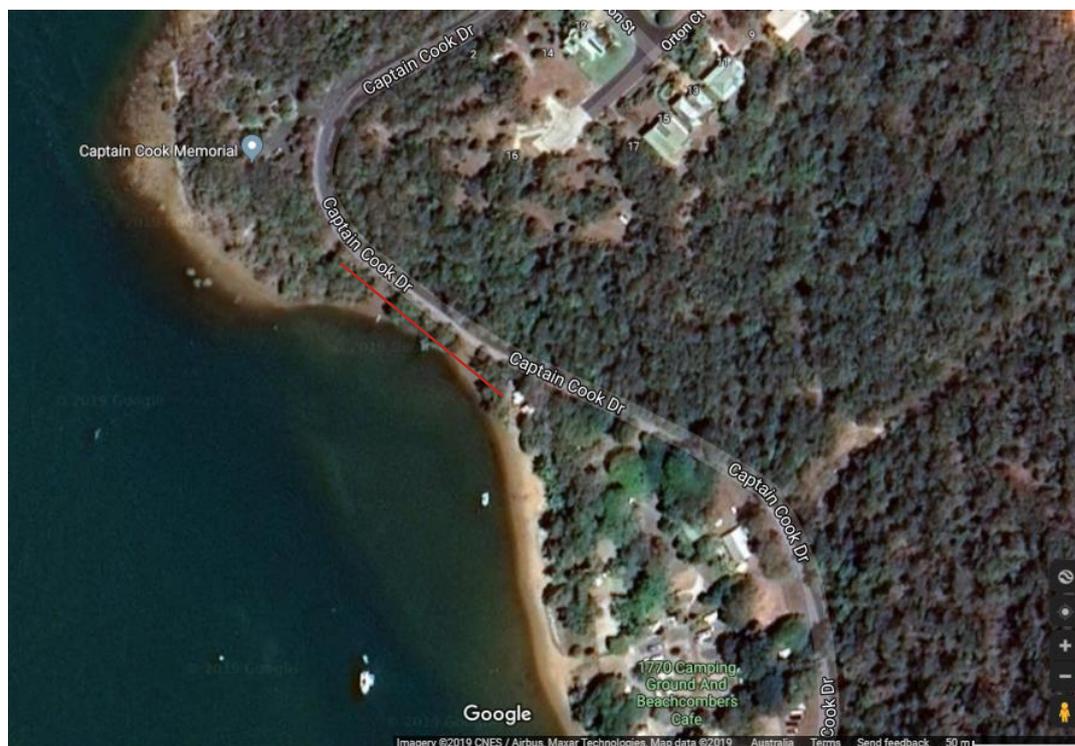
Figure 34. Section of Captain Cook Drive exposed – general extent for revetment works

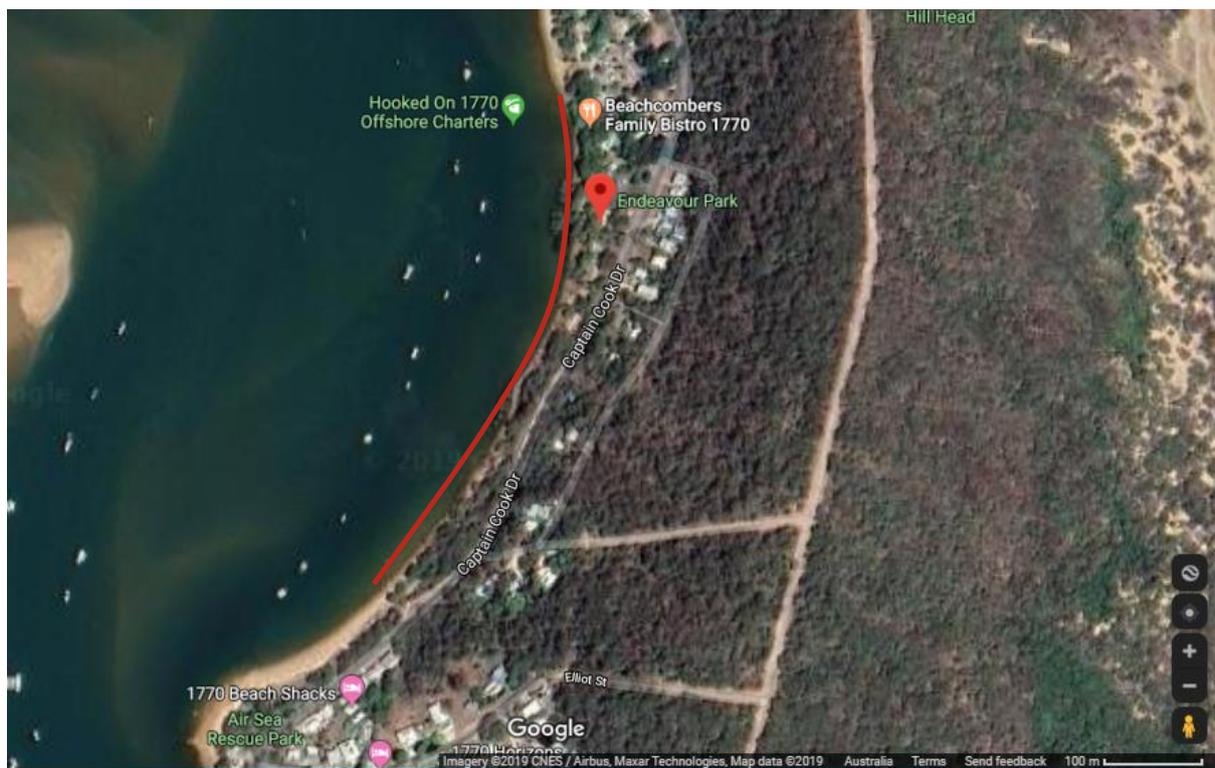
At the Seventeen Seventy main shoreline (Endeavour Park) (Figure 35) the ongoing erosion and tidal inundation concerns observed for the site over the next few decades may require:

Figure 35. *Seventeen Seventy main shoreline – Endeavour Park – general extent for erosion mitigation works*

If the preference for implementation of the current SEMP, over the next 20 years, is to actively manage the shoreline to maintain existing use, amenity and provide erosion protection to key assets, then the following options are considered for the main Seventeen Seventy shoreline.

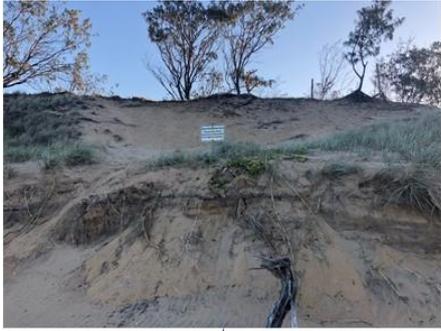
Erosion scarp

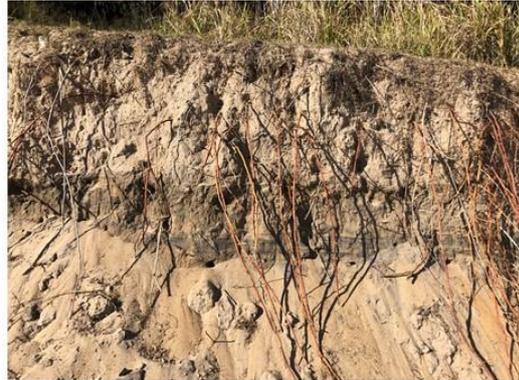
Exposed grass roots on dune erosion scarp

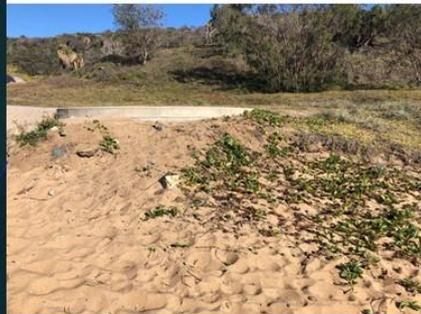
Desalination infrastructure on Chinamans Beach

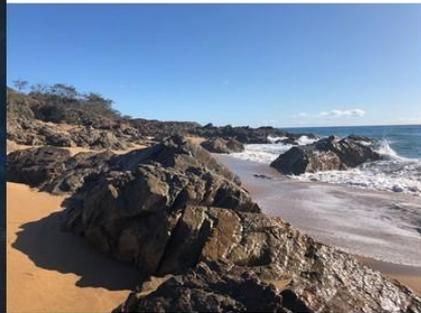
Exposed coffee rock

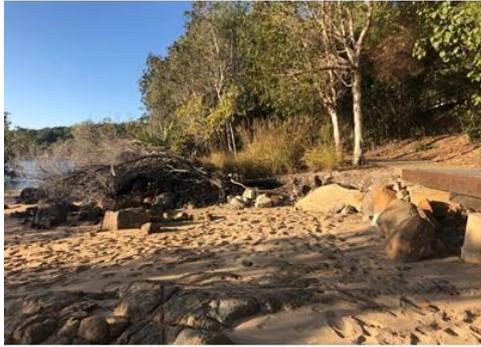
Section of boardwalk damaged by coastal processes

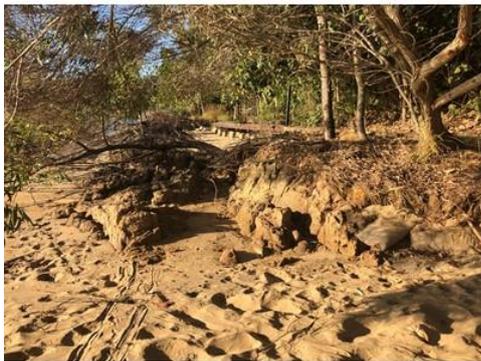
Erosion scarp with geobags placed to prevent further erosion
