Irrigation and soil assessment for Boyne Island Tannum Sands Golf Course

06th May 2020

Irrigation and soil assessment for Boyne Island Tannum Golf Course

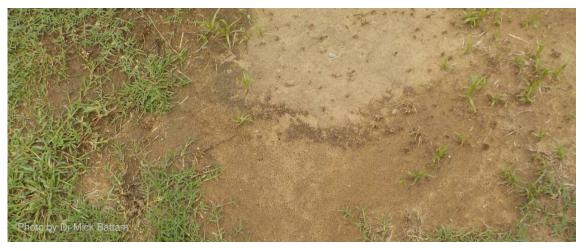
Figure E.1: The existing topdress is having no impact on the structure of the soil which is prone to hardsetting due to lack of organic matter and elevated sodium levels.

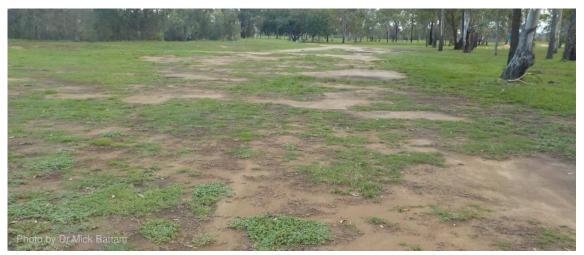
The assessment found thin or weedy cover across most fairways, with better cover at the north end of the course. Whilst some of this is attributable to interruptions in water supply, thin cover would likely be an issue in many of the narrower sections of the course due to a combination of compaction, competition from tree roots, limited weed control, low levels of nutrients and soil sodicity.

Figure E.2: Bare area that may improve slightly with fertiliser and weed control, but thin cover will likely persist until the issues of tree roots and traffic management are addressed.

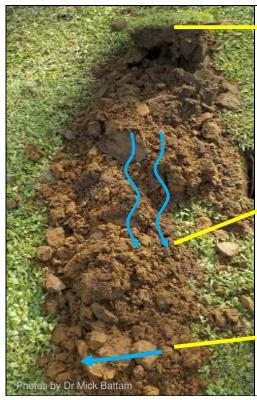
A1 horizon: 200 to 330 mm of sandy loam that was moderately structured

A2 horizon: 170 mm thick of yellow to tan coloured loamy sand to sandy loam. Water percolating down (waves arrows) through the profile is impeded by the B horizon and moves downslope in the A2 layer (across the top of the underlying B horizon). As such, this "wet zone" would sometimes be 170 mm thick

A1 horizon: 200 mm of sandy loam that was moderately structured. This horizon had been removed in some areas, with gravel observed at the surface.

Figure 2.1: Soil observed on the 5th and 6th holes. As with the soil on other sections of the course, water that percolates through the profile is eventually stopped by the clay and moves downslope across the top of this clay horizon.

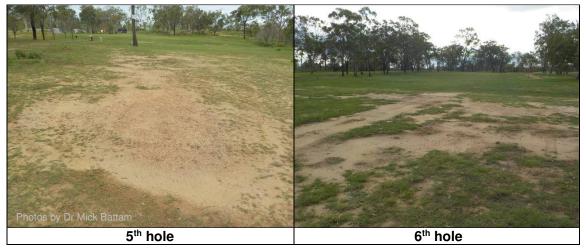
These areas are obvious, with the turf struggling to maintain cover and gravel often on the surface (Figure 2.3). Section 2.5 describes where additional topsoil can be obtained to amend these areas.

Figure 2.3: Areas that are struggling due to lack of topsoil.

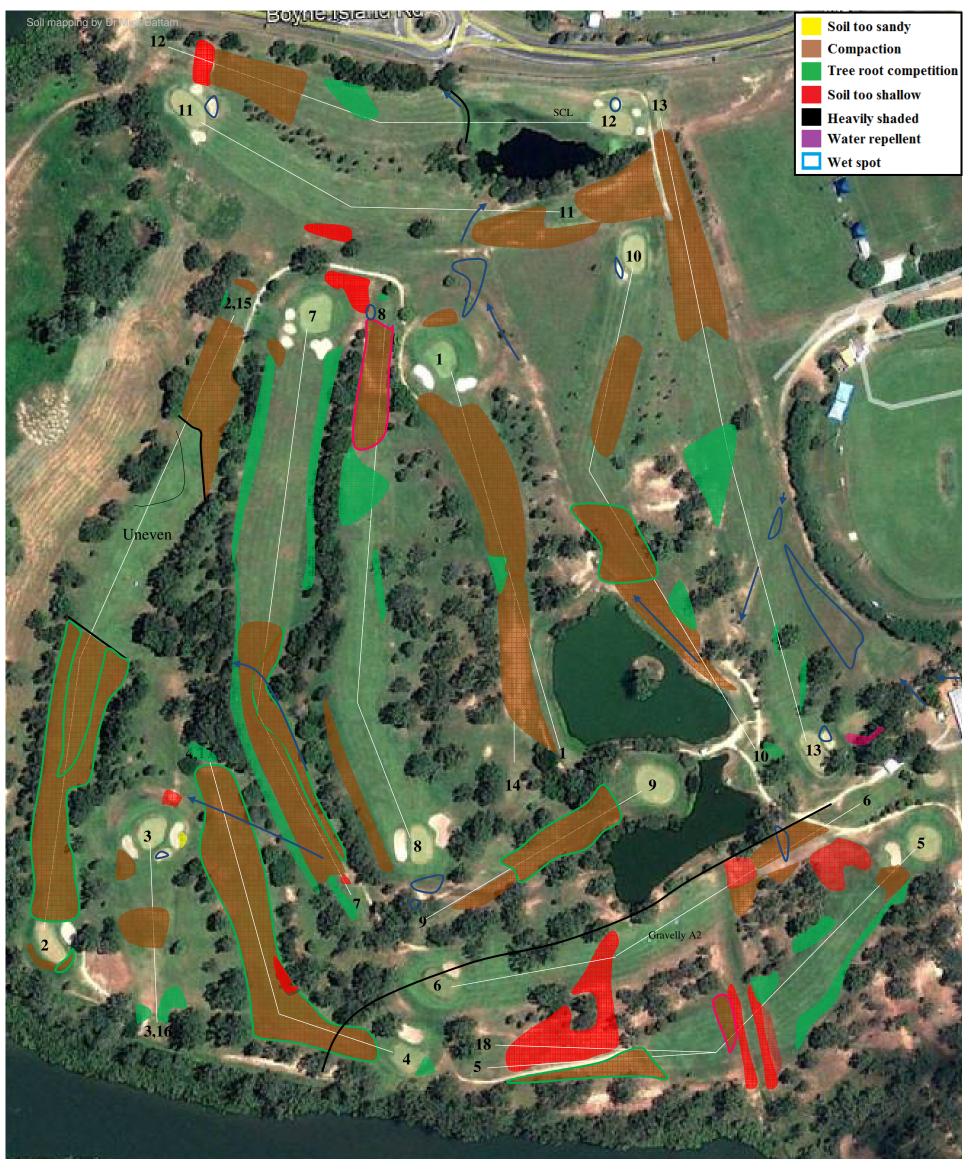
Figure 2.2: Factors limiting turf on the course. Google Earth image.

The topsoil was highly compacted in areas, especially on narrower fairways near the tees (Figure 2.2). Many of these problems could be overcome by effective traffic management, such as better definition of the cart access areas and using barriers. These can often be subtly installed by locating bins, garden beds or sand boxes in key locations. Wherever possible, try to locate the paths close to trees as the turf will always struggle in these areas. Due to the hardsetting nature of the soil, the importance of traffic management on this site cannot be emphasised enough.

By removing the topsoil prior to laying the path material, this will generate topsoil for use in amending shallow areas and filling depressions. The existing site soil is not only cheaper, but is far superior to the material that is currently being used for topdressing (Section 2.5).

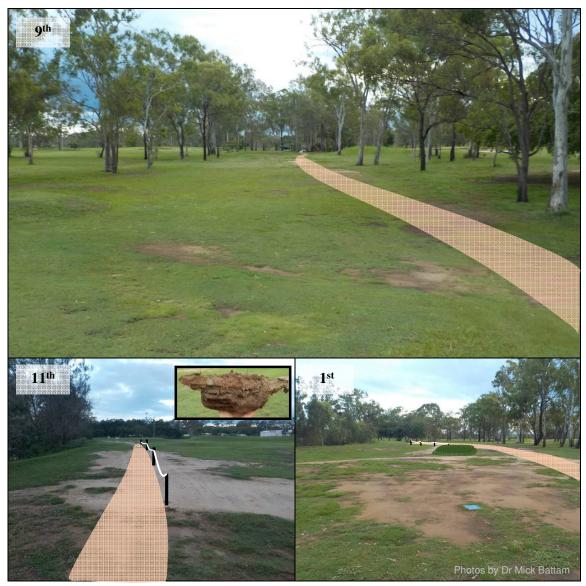
Figure 2.4: The thin turf areas could be majorly reduced by better defining paths and using "barriers" to encourage golfers to stick to these paths. These barriers can be fences (lower left), but traffic management can often be achieved by installing additional tee blocks (lower right), garden, garbage bins, water hazards or bunkers in locations that help direct traffic. As the turf will always struggle in areas close to trees, it is often better to install paths that cover these thin turf areas (upper and lower right).

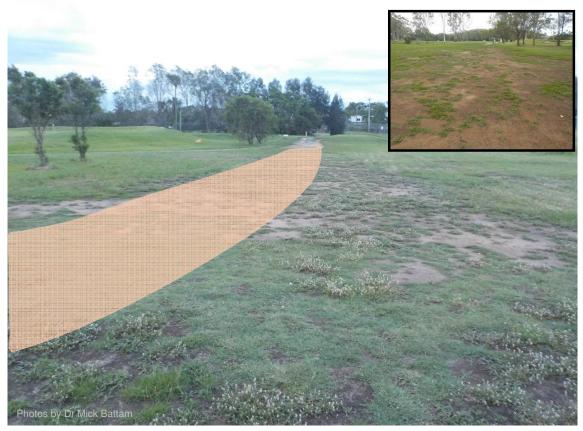
Figure 2.5: Other examples of large areas where the turf is struggling that could be minimized by better defining paths. Insert shows how hardsetting the soil can be.

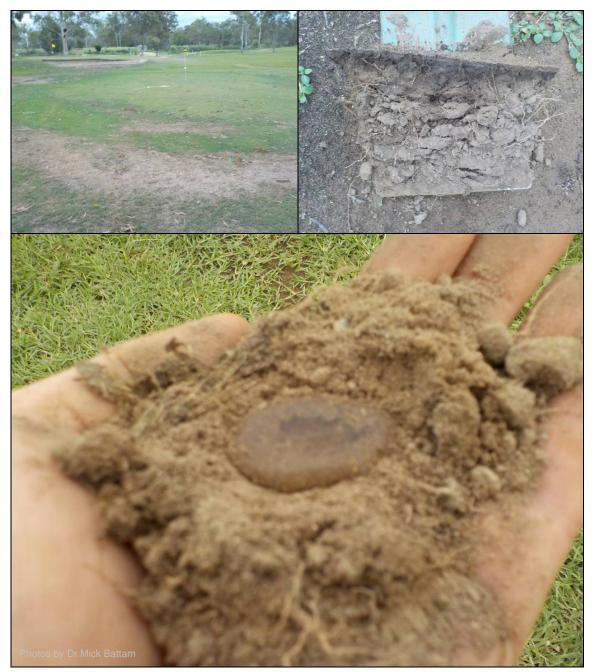
Despite the recent wet weather, the soil was completely dry in some locations due to water repellency (Figure 2.6). This was often observed in areas that were either highly compacted or steep sections of the course but was likely also a major issue on the greens (author was not able to verify without digging). Water repellency could be overcome by applying a wetting agent to the course at the end of each dry season. The wetting agent is most crucial for application to the greens, but it would ideally also be applied to tees, fairways and rough areas.

Figure 2.6: Turf struggling around the perimeter of a green (upper left) due to water repellency. This was also observed on other sections of the course, with the soil almost completely dry in some locations despite recent wet weather (upper right). Water repellency can be overcome through the application of a wetting agent.

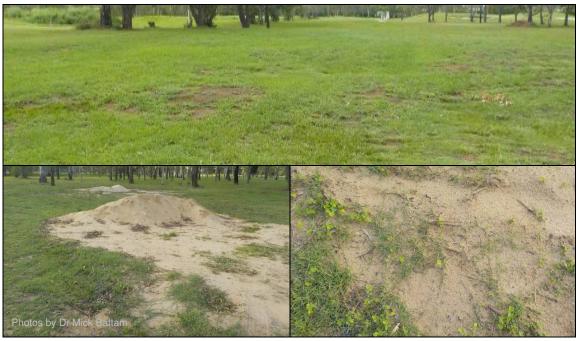
About 400 m^3 of topsoil could be harvested from the uneven area, with this being more than enough to ensure a topsoil depth of at least 180 mm can be achieved in all areas that currently have minimal topsoil (Figure 1.1). Excess material can then be used for topdressing, with the existing site soil far superior to the sand-based material that is currently being used (Figure 2.7).

Figure 2.7: By reconstructing the uneven area on the 2nd hole (upper), about 400 m³ of topsoil could be harvested and used to fill depressions and amend shallow areas on the course such as those on the 5th hole (insert). The existing site soil is far superior to the sand-based material that is currently being used (lower left), with the turf thin even in deep areas where it has been spread (lower right).

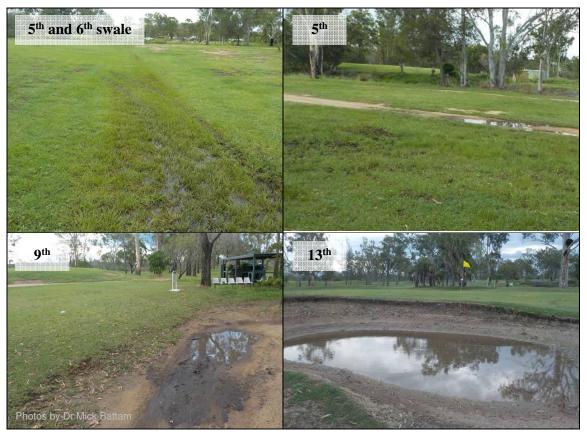
The site was inspected following 20 mm of overnight rain, with 80 mm having fallen two days prior. Most of the course drains well, with the biggest wet spot located in the rough along the east side of the 13th hole which receives surface water from the clubhouse roof and path areas. Waterlogging was also observed at the rear of the 1st green and in the swale between the 5th and 6th holes (Figure 4.1). As these wet spots are both located in rough areas that receive minimal irrigation they have an insignificant impact on the use of recycled water.

Figure 4.1: Most of the course drained rapidly after rain. Waterlogging was observed in localised areas such as the rough areas (upper), with these of minimal concern as they receive minimal irrigation. Of greater concern are areas that remained waterlogged for days yet are likely to be irrigated with recycled water such as bunkers and paths near tees (lower).

Waterlogging of the path can generally be overcome by filling the wet depressions and sloping the pathways so water runs into adjacent areas that are not trafficked so it can soak away. In contrast, it is a more difficult task to overcome the waterlogging that occurs in bunkers. Whilst the addition of calcium and polymers may overcome some of these problems, it is likely that drains may need to be installed (or cleaned out) in order to allow some bunkers to drain.

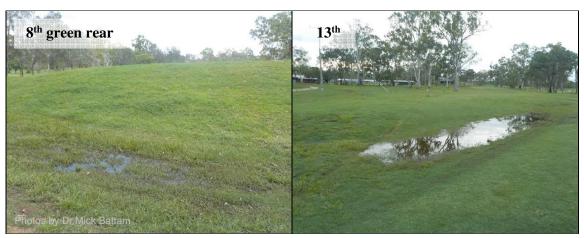
Figure 4.2: Waterlogging in low spots that could be overcome by gradually filling these areas with loam (do NOT use sand or waterlogging will persist), so surface water can flow downslope. Consider installing a surface drain in the 13th fairway swale, with this area receiving run on from the golf course buildings (via the rough) and BITS Sports Ground.

- **Fairway:** east side of the 13th (consider installing a surface pit or gradually filling the areas where water lies with loam so water runs downslope);
- Green surrounds: depression at the rear of the 8th green (gradually fill this area with loam);
- **Bunkers:** beside 3rd, 10th, 11th, 12th and 13th greens, with signs of siltation also observed in other bunkers; and
- **Paths:** beside the 8th and 9th tees. Water was also observed lying on the path in front of the 6th tee, but this area receives minimal irrigation.

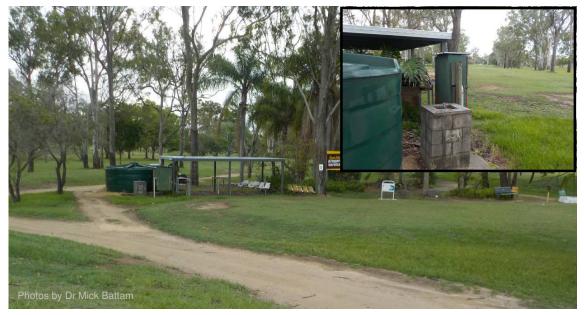
Rainwater is harvested from a small roof area that provides shelter for golfers waiting near the 9th tee. Unfortunately, spray drift is likely to result in some recycled water landing on the roof that captures rainwater (Figure 5.1) or the adjacent drinking bubbler. Apparently, this bubbler has been decommissioned. If this is correct, ideally, it would be removed. Alternatively, the bubbler should be located under the roof with a backing barrier to prevent it being covered by spray drift. Additionally, the rainwater tank outlet should have non-potable water signage installed.

Figure 5.1: Due to its close proximity to the 9th tee, recycled water is likely to spray onto the adjacent roof that is harvesting rainwater or the adjacent drinking bubbler (insert). The irrigation system needs to be set up so this does not occur.

To avoid recycled water being sprayed on the roof, it is recommended that the irrigation system be designed so water is sprayed away from the roof, with low angle sprinklers used in the adjacent areas.

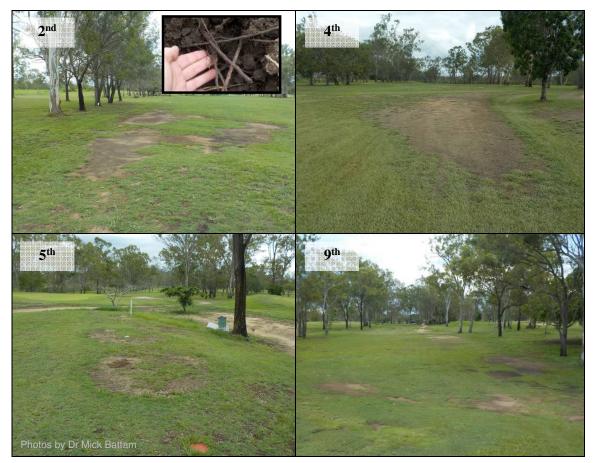
- **Tees:** on the 3rd, 4th, 5th (Figure 6.1), 7th, 10th and 16th holes, with minor issues also observed on the 2nd and 8th holes; and
- **Greens:** likely on the 2nd, 4th, 13th and the adjacent green. Due to concerns raised about damage to the greens, the author was unable to verify which greens actually had tree roots.

Figure 6.1: Thin turf from tree roots was observed on some greens (upper left) and tees (upper right), but was a major problem along the side of most fairways. Whilst a root barrier should be installed in some locations, routine aeration with the earthquake would root prune.

Ideally these problems would be overcome by installing a high-density polyethylene sheet such as "root barrier" (manufactured by Polyfabrics Australasia or equivalent). This should be installed to a depth of about 800 mm at this site. If the cost is prohibitive then this should at least be considered for installation around the effected greens (verify first whether roots are an issue), tees and on the narrower fairways that are struggling to maintain turf cover e.g. 4th hole.

In the short term the roots could be pruned using a slicer such as the earthquake. Alternatively, the invading roots could be manually pruned using a sharp spade to cut a deep slice around the perimeter of the affected greens or tees. The dead patches in the tees will continue to increase in size until the offending roots are cut. Wherever possible, locate paths in areas where tree roots are adversely affecting the turf so these struggling areas are covered (Section 2.3).

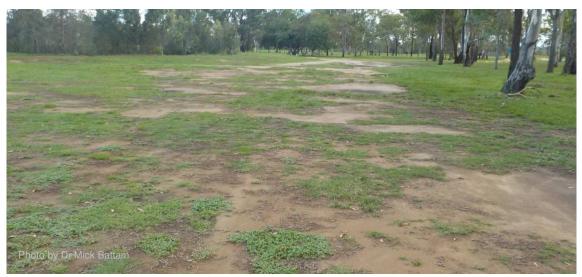
Figure 6.2: Bare area that may improve slightly with fertiliser and weed control, but thin cover will likely persist until the issues of tree roots and traffic management are addressed.

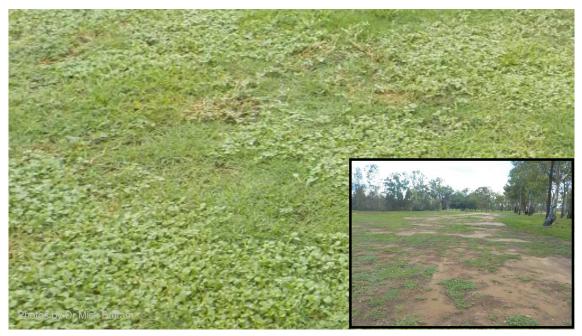
Figure 7.1: Given the large numbers or weeds and areas of compacted bare ground (insert), consideration should be given to spraying out the existing ground cover, amending the soil (so it is less prone to hard setting) and establishing a suitable turf cultivar from sprigs.

Depending on the time of year these works are performed (and the couch cultivar), acceptable turf cover could be achieved following sprigging in about a 10 to 15-week period. To perform these works over the entire course (except the northern two holes) would cost about \$1,320,000+GST, with this assumes a contractor maintains turf until 90% ground cover. However, this could be significantly reduced by having a staff member oversee turf grow in (following initial sprig establishment).

Reconstruction could be performed in stages that follow the installation of the new irrigation system and tree root barriers (crucial), so that 9 holes always remain in play at all times.

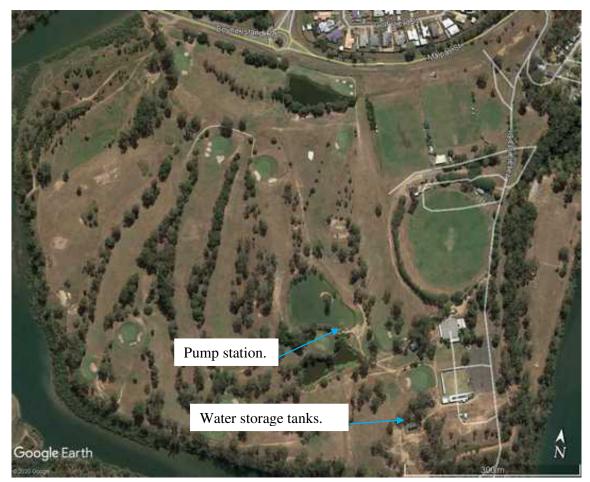
Figure 8.1: Water storage tanks and pump station located at BITS Golf Course.

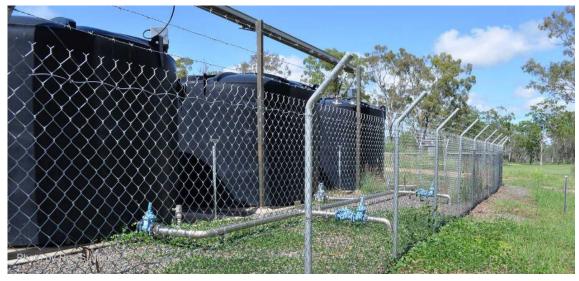
Figure 8.2: Water storage tanks located at BITS Golf Course.

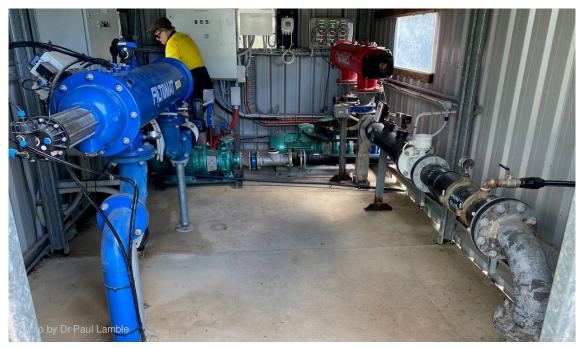
The irrigation pumps are in the pump shed on the golf course (Figure 8.3). There are two separate pump sets in the pump room, with one supplying the golf course and the other supplying the sports fields. The pumps are Southern Cross MGC14A-F model 80X50-250 22kW with a 229-mm diameter impeller. These pumps have a nominal duty range of approximately 10 L/Sec (1100 kPa) to 28 L/Sec (850 kPa), with a pump performance curve provided in Appendix C.

Figure 8.3: Irrigation pump station.

The pumps configuration should be reconsidered, with single impeller single stage centrifugal pumps such as these are generally more suited to supplying a stable volume output, even if variable speed controllers are installed. By comparison, golf course irrigation systems typically have varying flow rates as the system is being used to water different sized areas, with greens, tees and fairways often having sprinklers with different flow demands. For these variable demand systems, multistage pump sets (with variable speed control) are a much more suitable alternative.

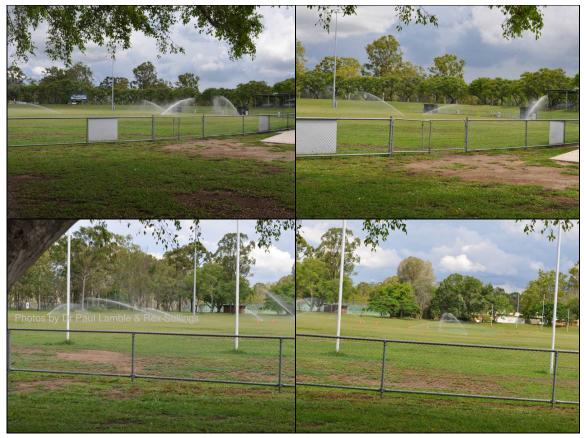
Due to operating time constraints staff are routinely irrigating multiple areas at any one time. Several solenoid control valve wires have been "doubled up" at the controller output terminals. This practice can result in dramatically reductions in operating pressures and generally results in very uneven watering which was clearly evident during irrigation of the nearby AFL Oval (Figure 8.6). This situation may be largely avoided with an upgrade to an irrigation controller with flow management capability, as suggested in Section 8.6.

Figure 8.6: Irrigation station on AFL Oval operating as a single station (upper left) and in conjunction with another station (upper right). Further examples of low operating pressures in the lower images.

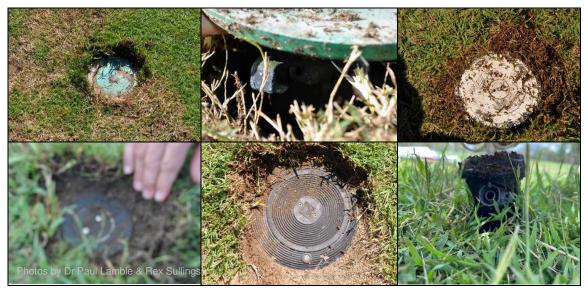
Different sprinklers (even when fitted with precisely the same nozzle) do not necessarily provide the same performance in terms of the evenness of distribution of water over the target area. The different effects of the sprinkler and the nozzles along with the operating pressure result in different distribution patterns along with different application rates. The presence of different sprinklers on a common irrigation lateral line is not a good practice, however common it may be, and cannot result in even distribution of water.

Figure 8.7: A sampling of the many different types of sprinkler present at the BITS Golf Course greens – Rain Spray, Rapid Rain, Rain Bird Eagle 700, Perrot and Hunter I-25.

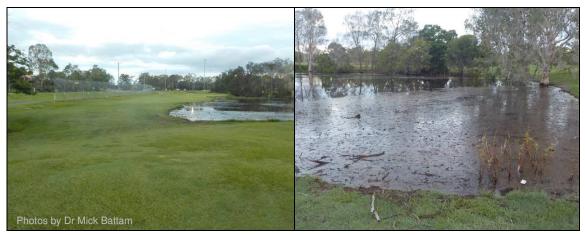
Although nitrogen is of minimal concern with regards to irrigation, monitoring found that total nitrogen levels are often higher in the dam located adjacent to the 12th fairway (Figure 10.1). As faecal coliform levels are often higher in this relative to the dam across the road it is likely due to either direct over spray or run-off from the irrigation system (Alpha Concepts, 2017 to 2019). To prevent this from occurring the sprinklers in this area should be adjusted to ensure an unirrigated buffer of at least 2 m is maintained around the side of the dam. It should be noted that some of the nutrients in this dam may be the result of runoff from fertilisers applied to the adjacent fairways.

Figure 10.1: Close proximity of the dam on the 12th hole to the fairway, with six monthly monitoring finding BOD, TP and TN are often higher then observed in the control dam.

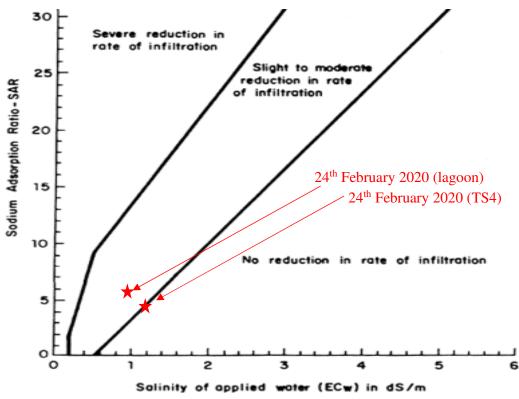
These results suggest sodium levels are increasing and have already exceeded the 6% value at which soil structural problems are more likely to occur. To ensure the site continues to drain effectively, it is recommended that significant amounts of calcium be routinely applied to the site in the fertiliser program. In addition, ongoing monitoring of ESP levels within the soil are needed.

Figure 10.2: Water sampling results showing there is a slight to moderate likelihood of decline in soil infiltration rate due to the ratio of sodium and salt within the recycled water.

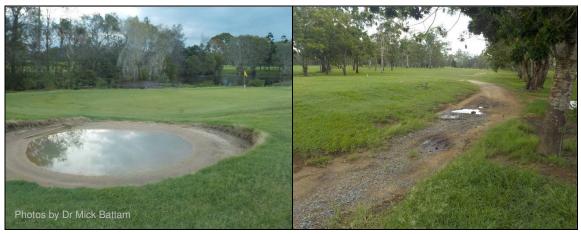
When the course was inspected recently following rain, water was observed lying for days in several greenside bunkers, with these typically wet by sprinklers watering the greens. This is concerning as golfers will likely retrieve their wet ball from ponded areas and some may even attempt to play from semi waterlogged areas. To prevent this from occurring it is recommended that irrigated areas that are prone to waterlogging be amended. In the short term, green side bunkers should be pumped out prior to commencing irrigation events (Figure 10.3).

Figure 10.3: Water lied in this bunker for several days after rain (left). If these areas were irrigated then there is a high chance of golfers coming into direct contract with recycled water. Water also lied in the path areas that were watered by tee sprinklers (right).
