Round Hill Creek Channel Options

Reference: R.B23355.001.01.docx

Date: January 2019

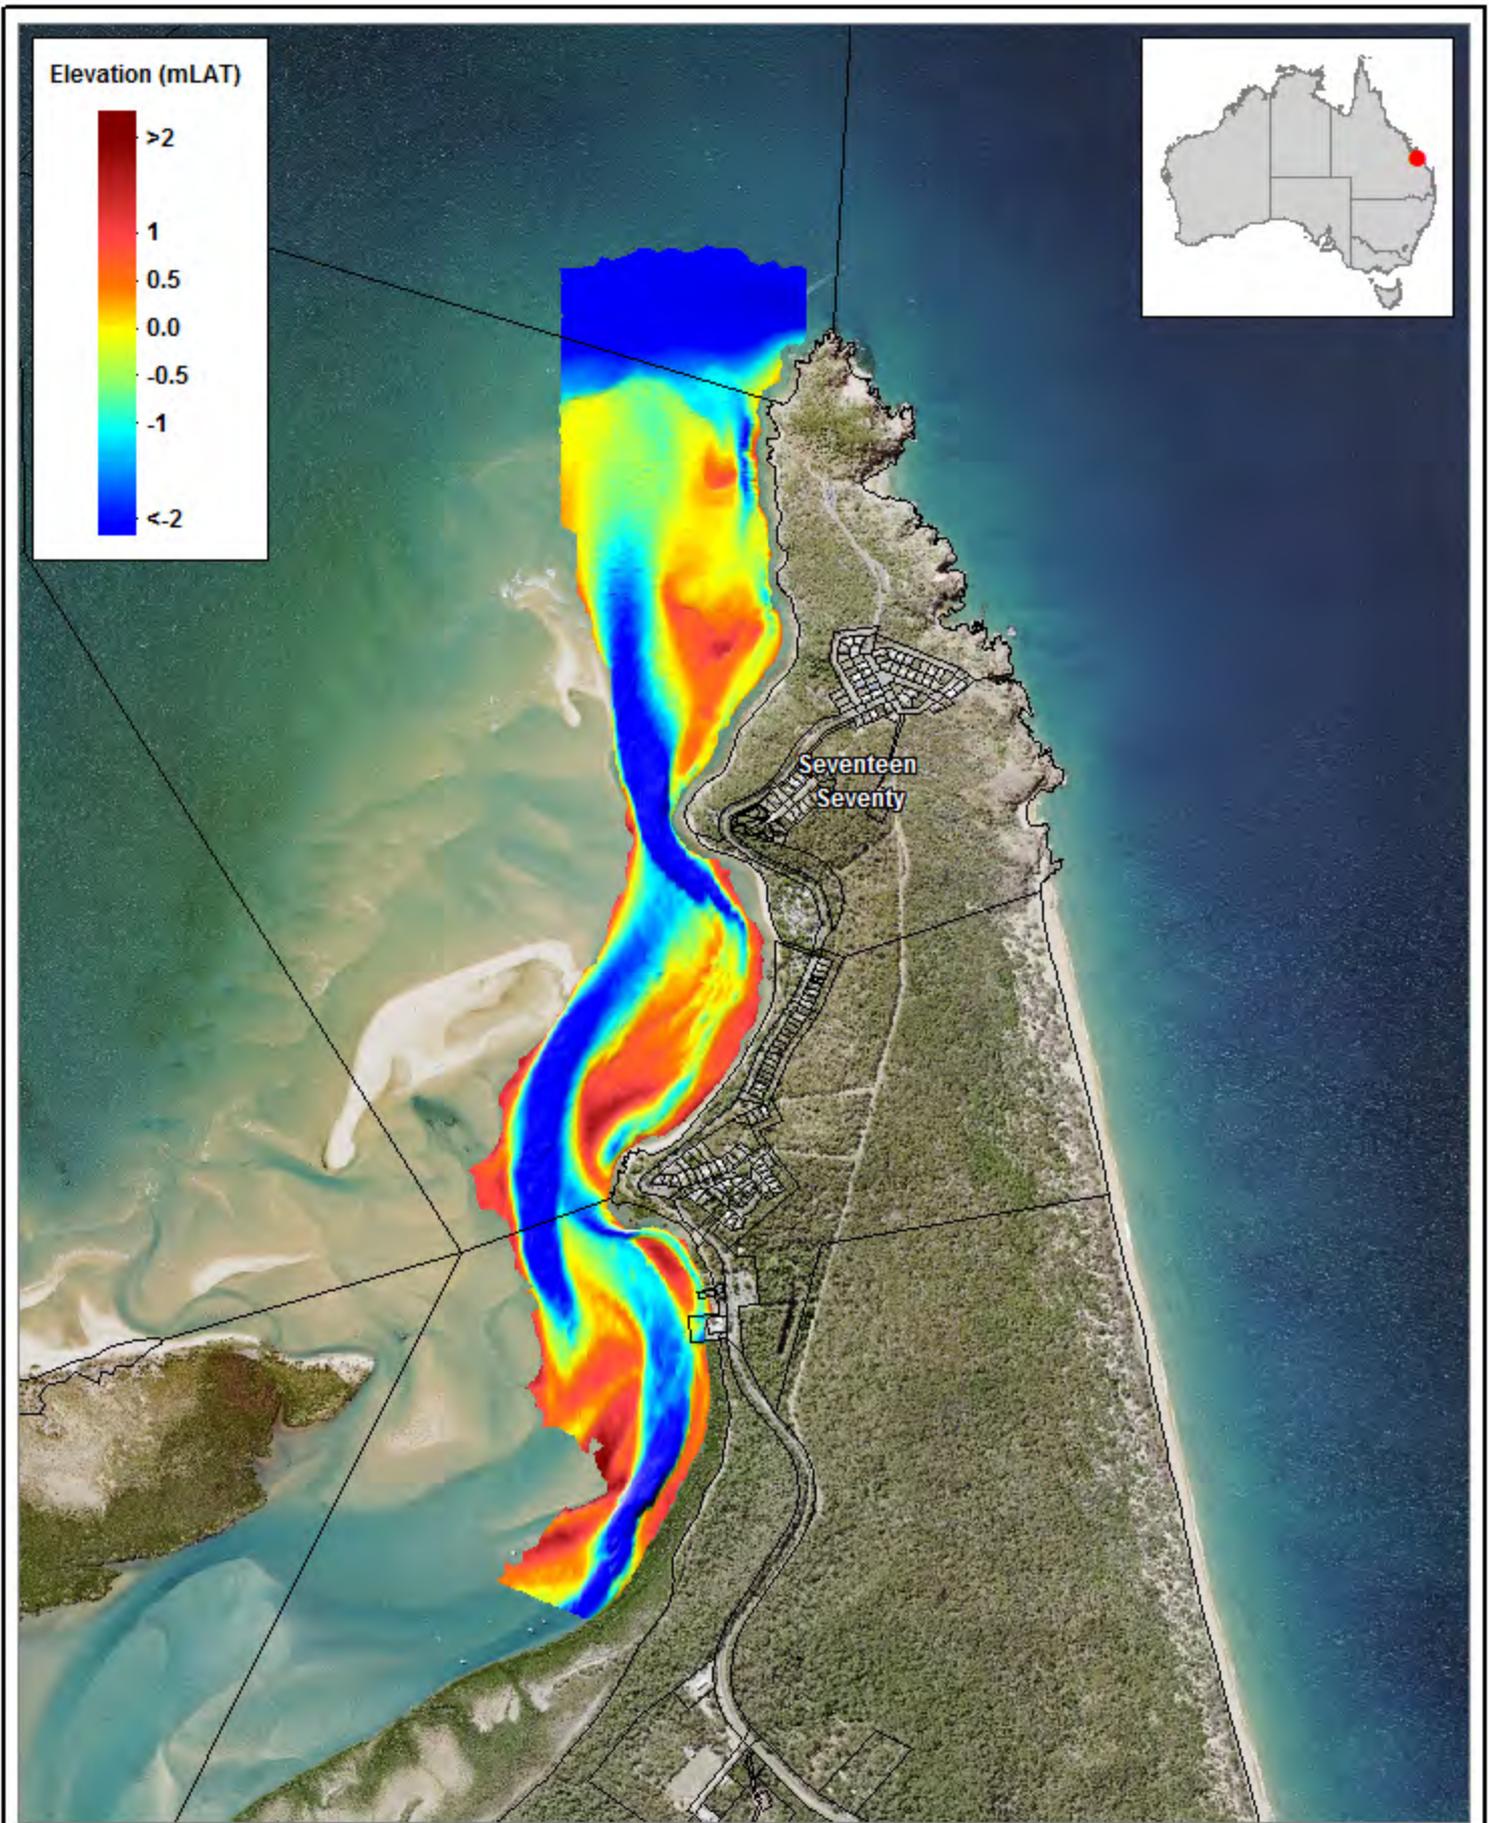
Figure:
3-1

Title:
**14 September 2018 Survey Data
(2017 Aerial Image)**

The previous report recommended that an up to date survey be obtained to ascertain the recent changes and this was captured by Maritime Safety Queensland (MSQ) on 18 September 2018. Figures showing the 2018, 2016 and 2014 surveys are presented in Figure 3-1 to Figure 3-3. The difference in bed elevation between the 2018 and previous 2016/17 survey is also plotted in Figure 3-4.

These clearly show the continued growth of the sand shoal seaward of Monument Point and the resulting increased constraint on navigation across the entrance bar. The bed elevations in the vicinity of the previous cross-over channel between the red and green buoys are now above the level of the Lowest Astronomical Tide (LAT) which means it essentially dries completely on the very low spring tides. While the channel heading straight out has now deepened a little, it is still only 0.5m deep on the lowest low tides.

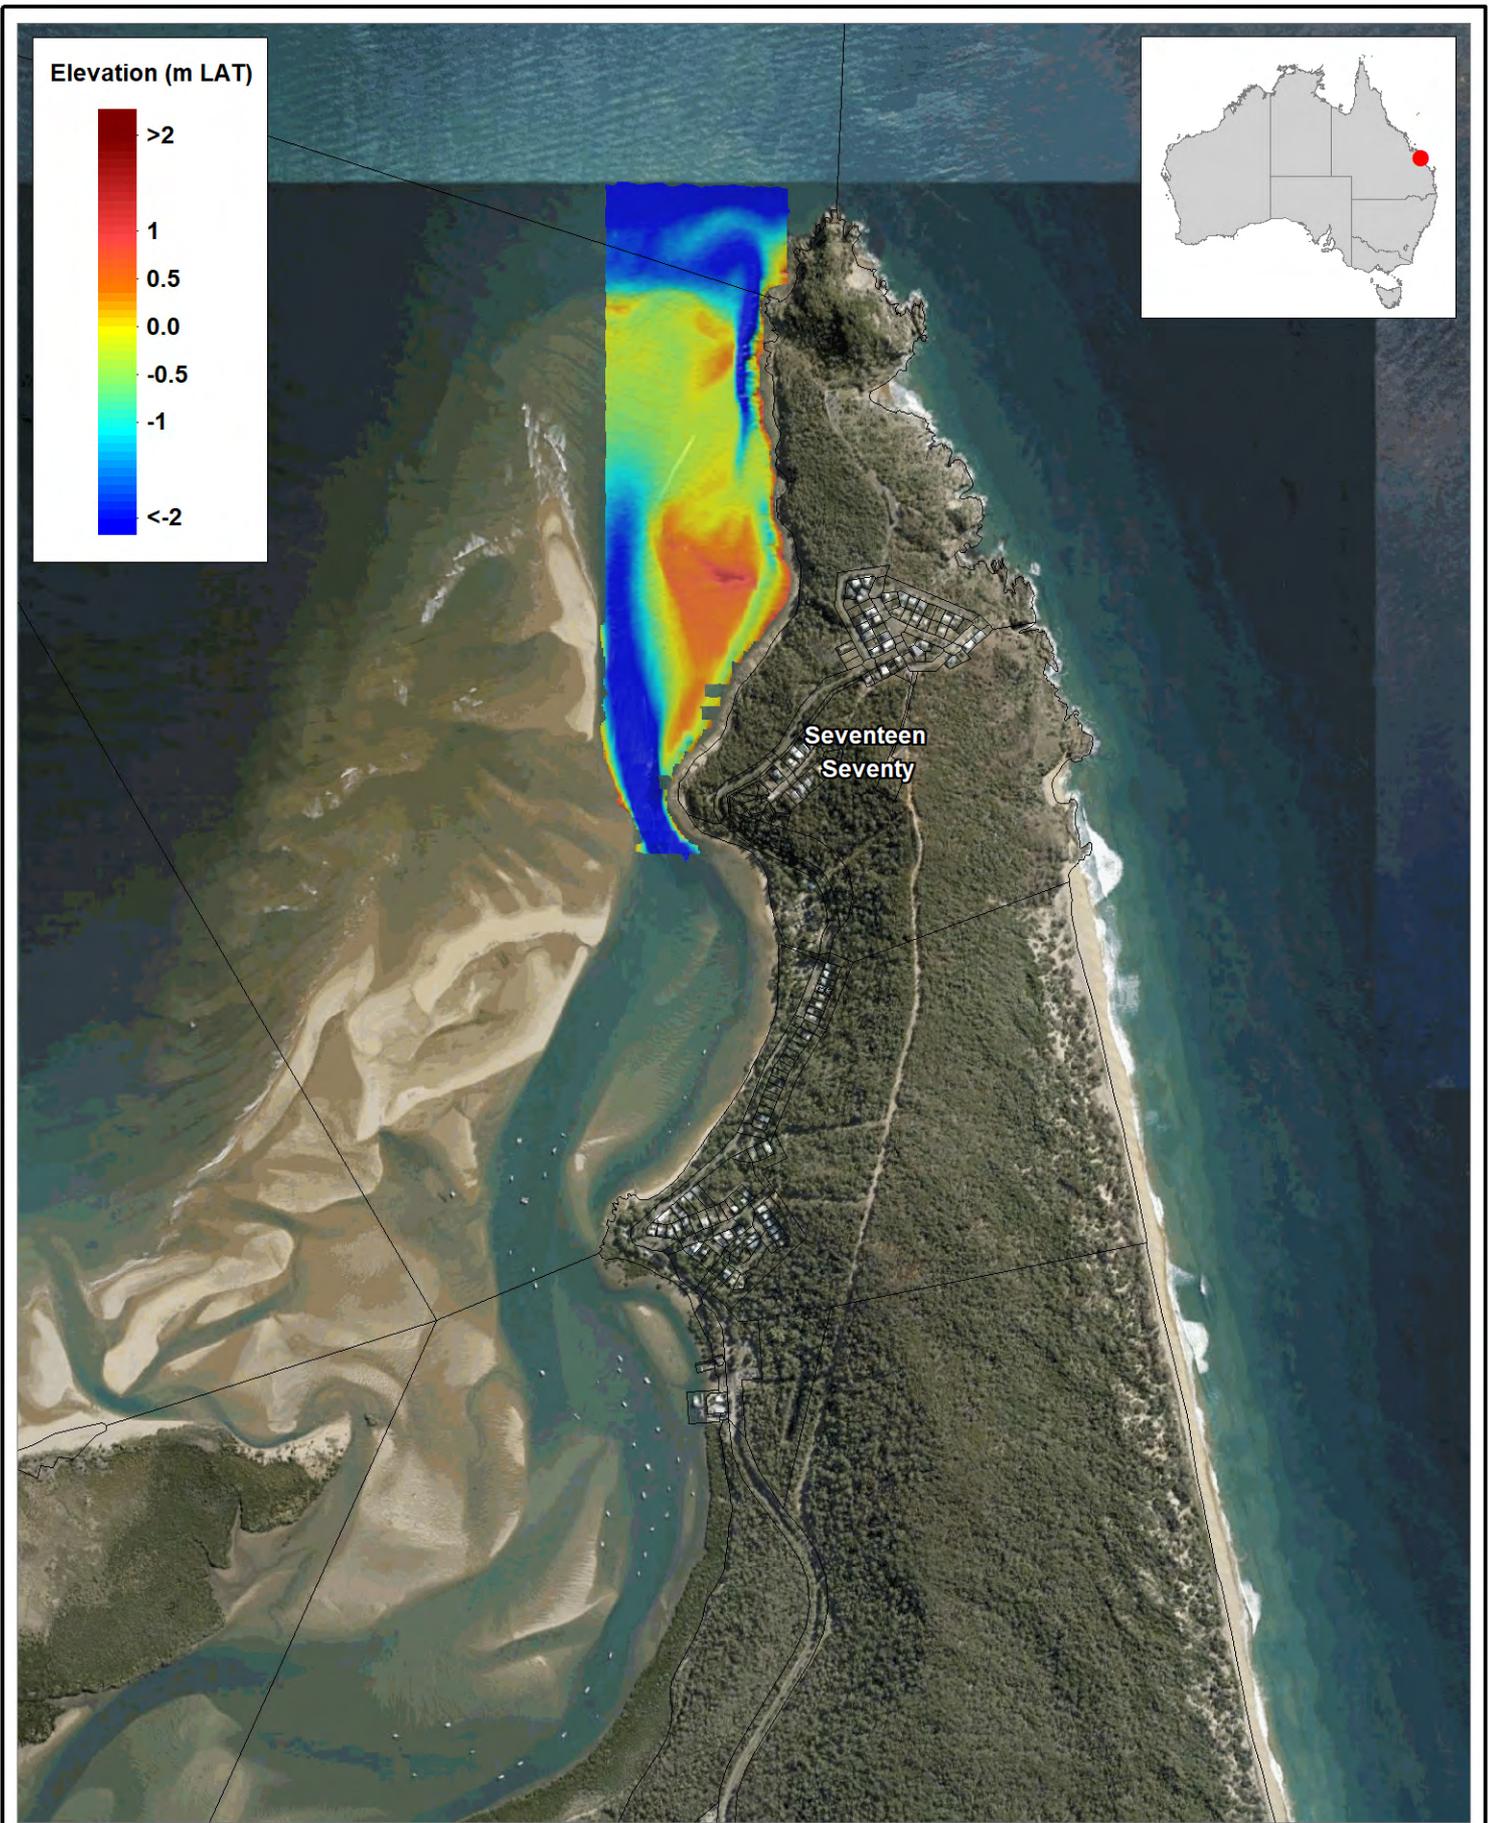
Figure:
3-2

Title:
7 December 2016 Survey Data

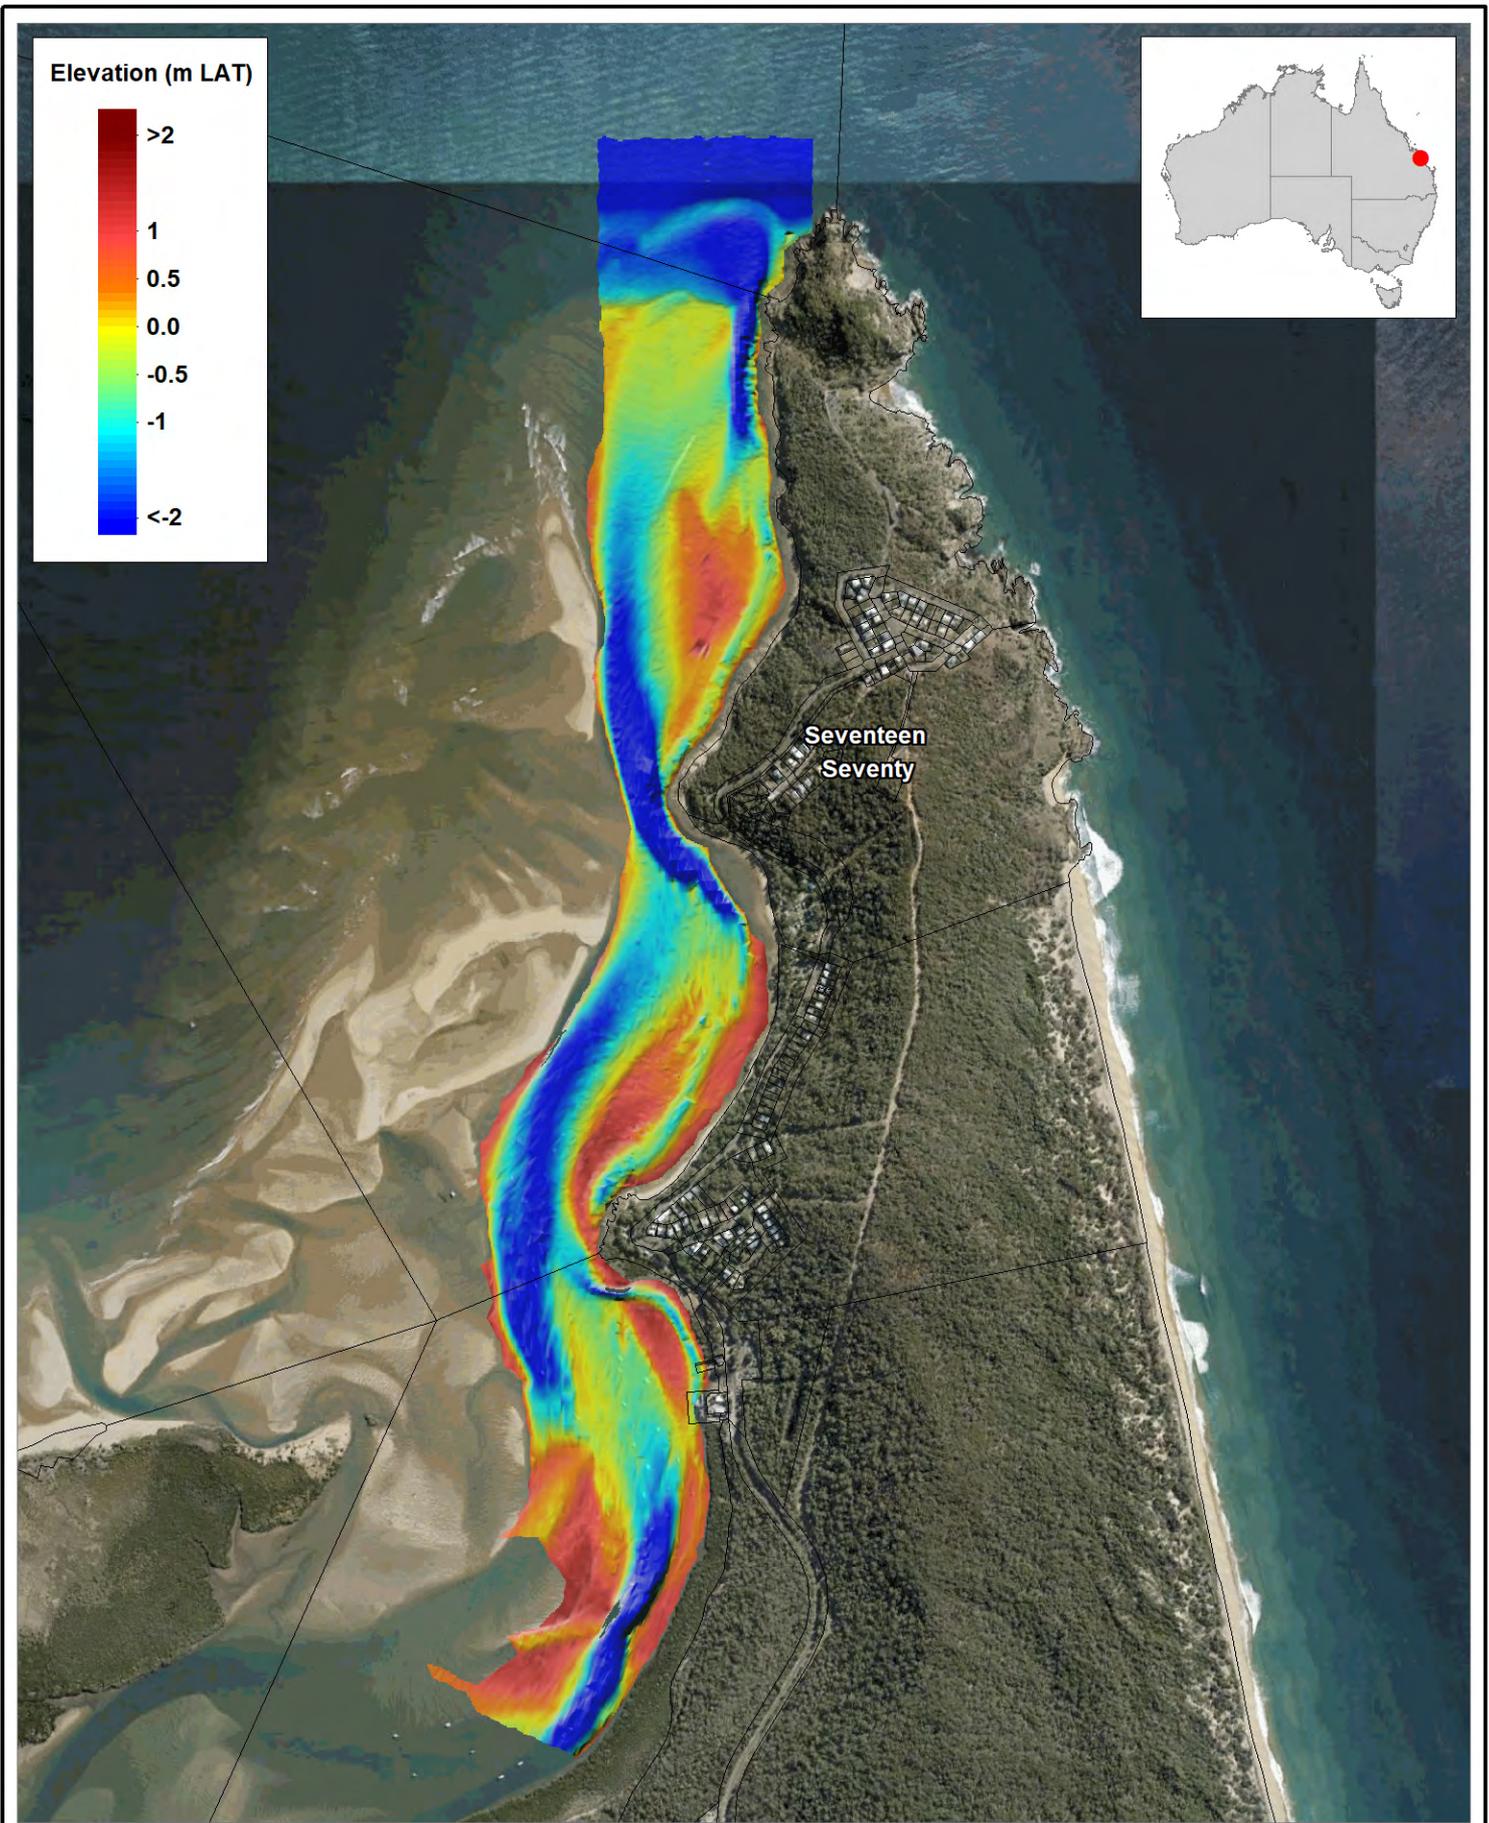
Figure:
3-3

Title:
17 November 2014 Survey Data

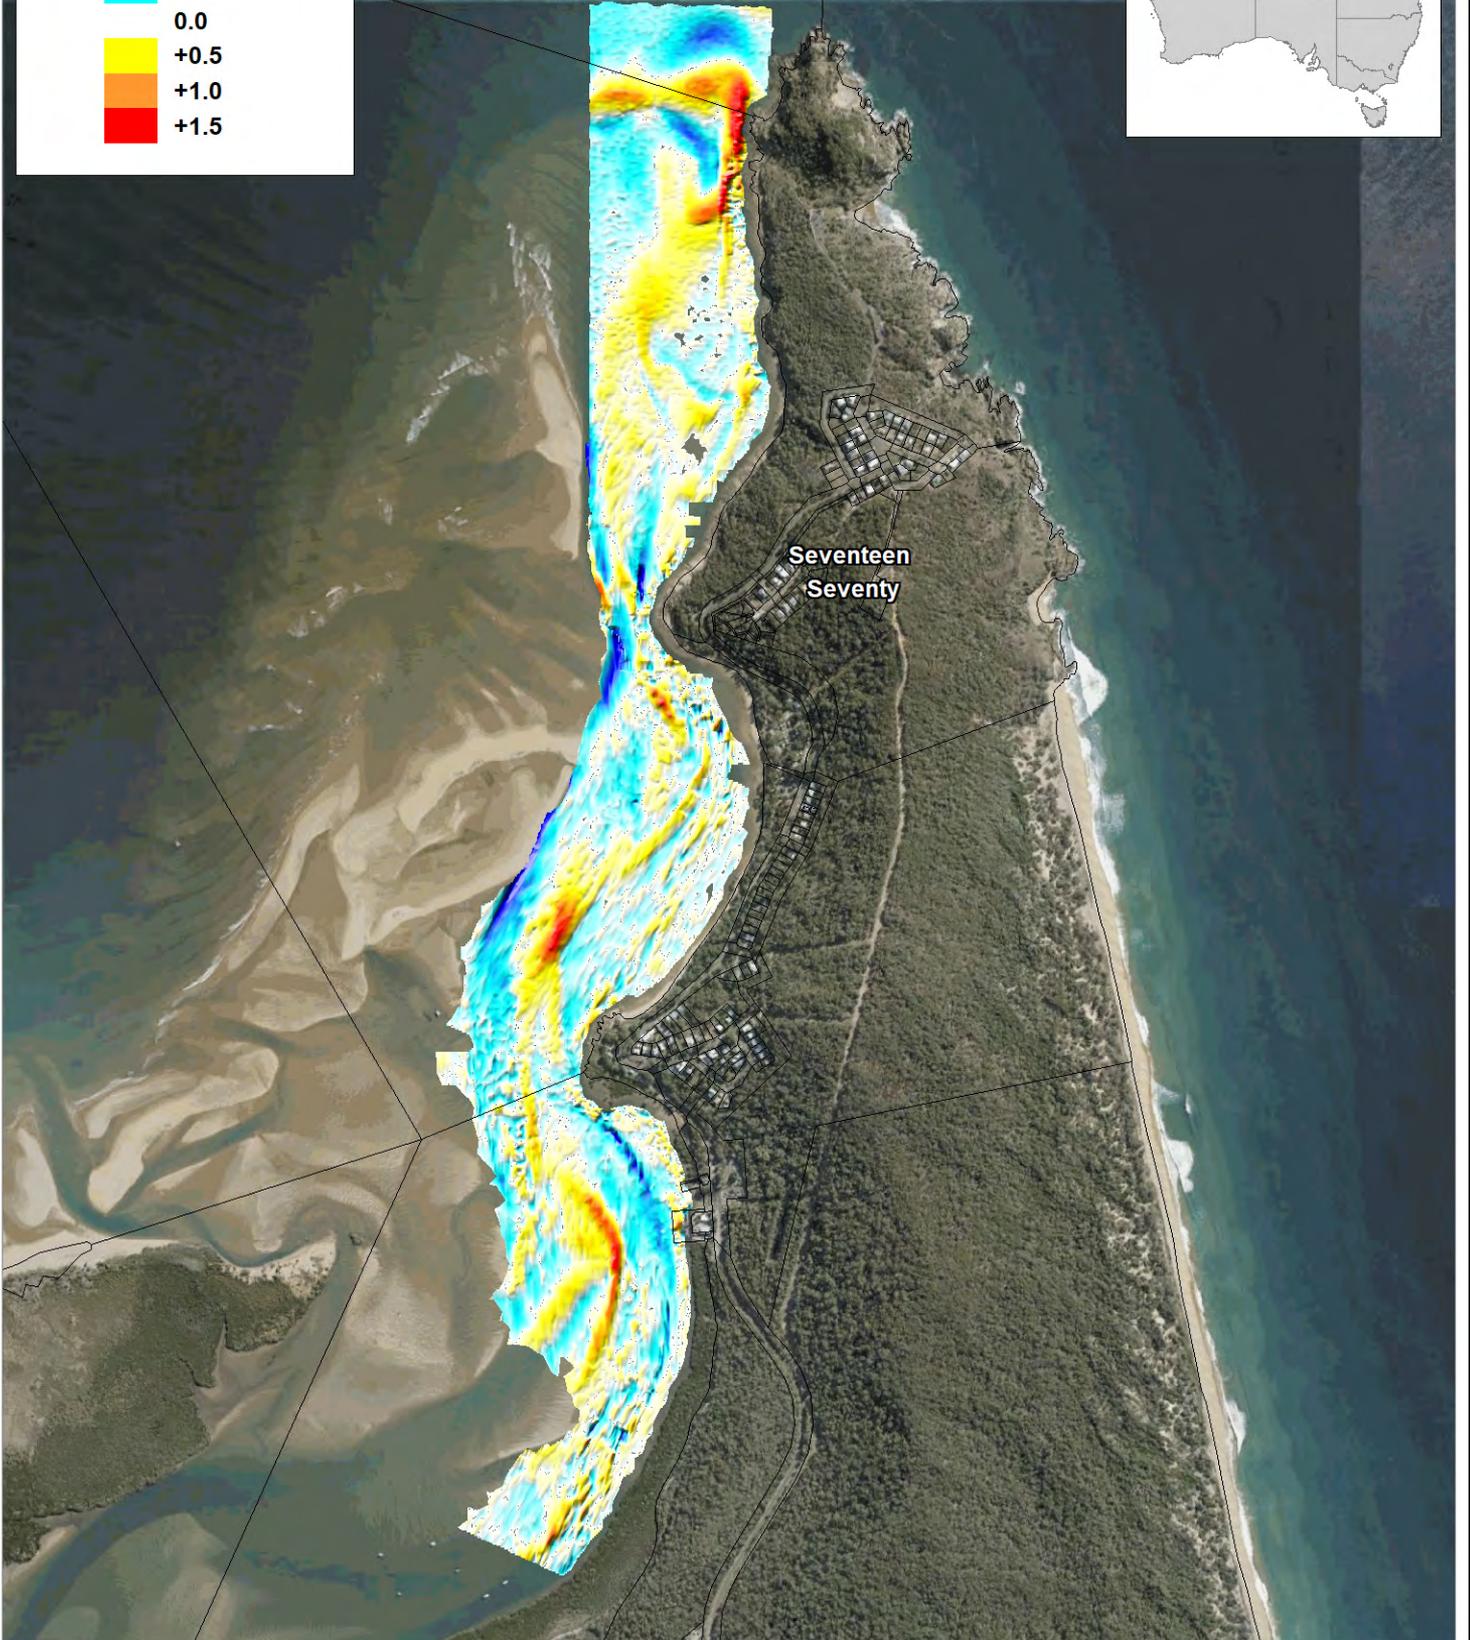
Figure: **3-4**

Title: **Difference in Elevation between 2018 and 2016/2017**

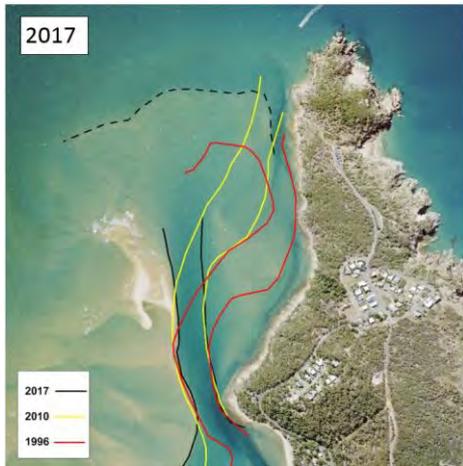
Figure 3-5 Recent Channel Locations shown on 2017 Photo

The dynamic nature of the channels at the entrance is captured in Figure 3-5 to Figure 3-7 which show the main navigation channel in 2017, 2010 and 1996 (channel outlines traced from the relevant aerial photograph). The significant changes which have occurred over this 11 year period give an indication of the challenges which will be encountered if interventions to stabilise the entrance channels are considered. The full set of aerial photographs is contained in Appendix A. Of particular note is that up until about 2010, a relatively narrow and therefore deeper channel tended to persist and meander over towards the headland at the outer (northern) end, with the western side of the channel being constrained and defined by sandy shoals. Since that time, the western shoals at the entrance have tended to migrate further west with the entrance channel becoming broader and shallower. As discussed above, the previous cross-over channel to the deep channel near the headland has now essentially gone with the channel heading straight out now tending to become more dominant, albeit being broader and shallower. It is also relevant to note that waves break along the shallow outer edge of the ebb tide delta of that main channel as illustrated in Figure 3-8. This is a navigation constraint and also exemplifies the dynamic processes occurring.

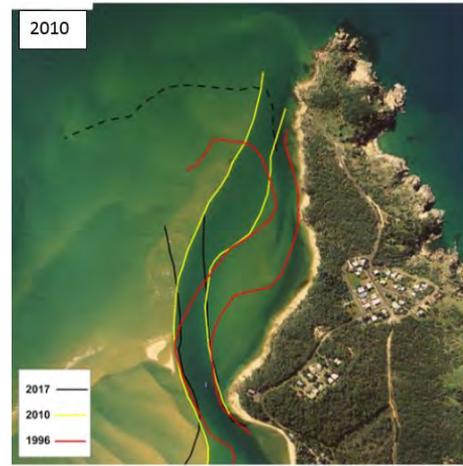
Figure 3-6 Recent Channel Locations shown on 2010 Photo

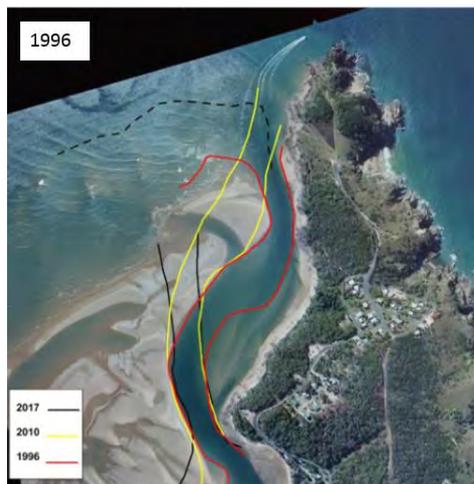
Figure 3-7 Recent Channel Locations shown on 1996 Photo

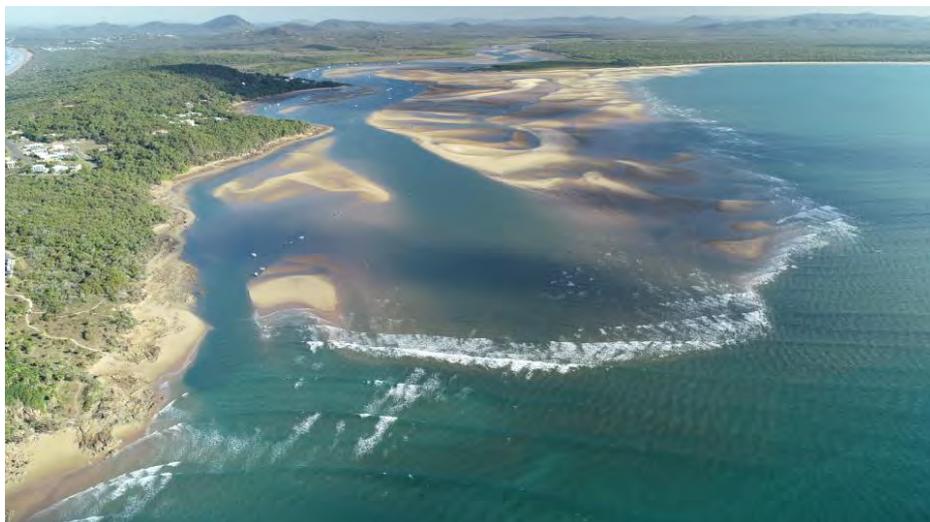
Figure 3-8 Waves Breaking Across Outer Shoal

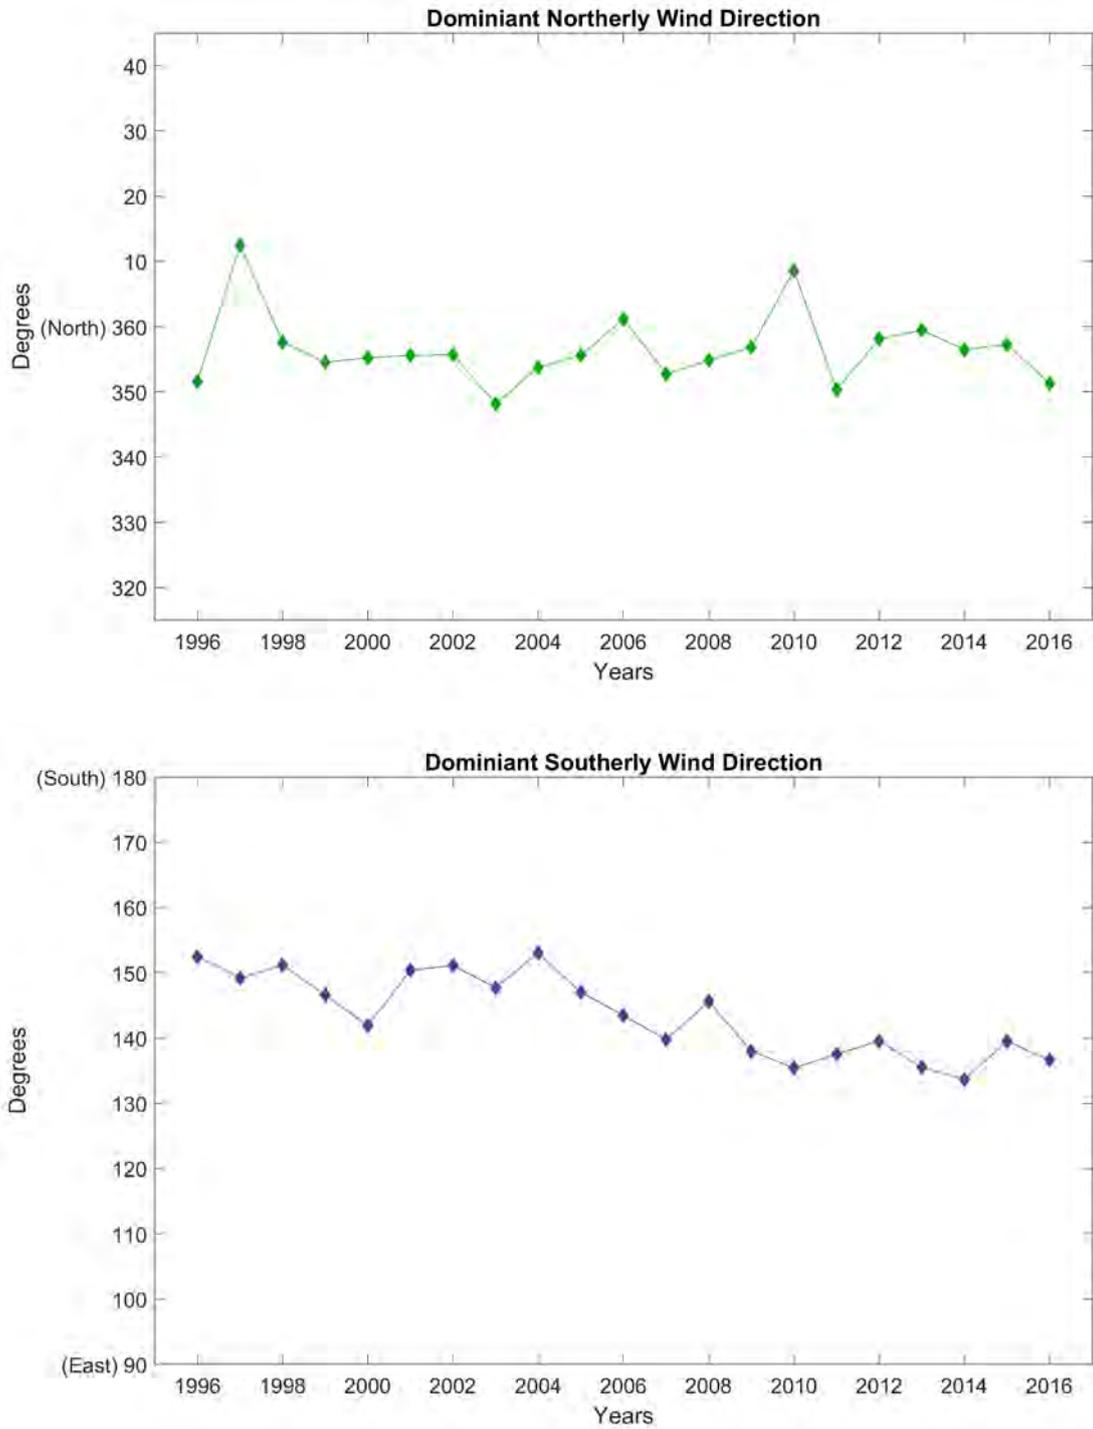
Figure 3-9 Annual Dominant Wind Directions

Wave driven longshore transport of sand past Round Hill Head and into the entrance of Round Hill Creek is a key contributing factor. To gain further insight into the observed changes, wind records from Double Island Point since 1996 were analysed as a further indicator of potential changes in regional wave patterns and hence sediment movements. Annual wind roses from 1996 to 2006 are presented in Appendix B together with the dominant wind speed weighted direction for the southerly and northerly sector winds. The annual dominant wind directions are also plotted in Figure 3-9 which illustrate the annual variability. It also shows that while the dominant northerly winds have fluctuated around a fairly constant direction, a trend is evident in the southerly winds over the last 20 years with an apparent gradual shift in the dominant wind direction from SSE (157.5deg) to SE (135deg). Any such shift could be expected to be also reflected in the wave conditions and alter the patterns of sand transport across and into the entrance of Round Hill Creek with flow on affects for the channel and shoal behaviour of the entrance.

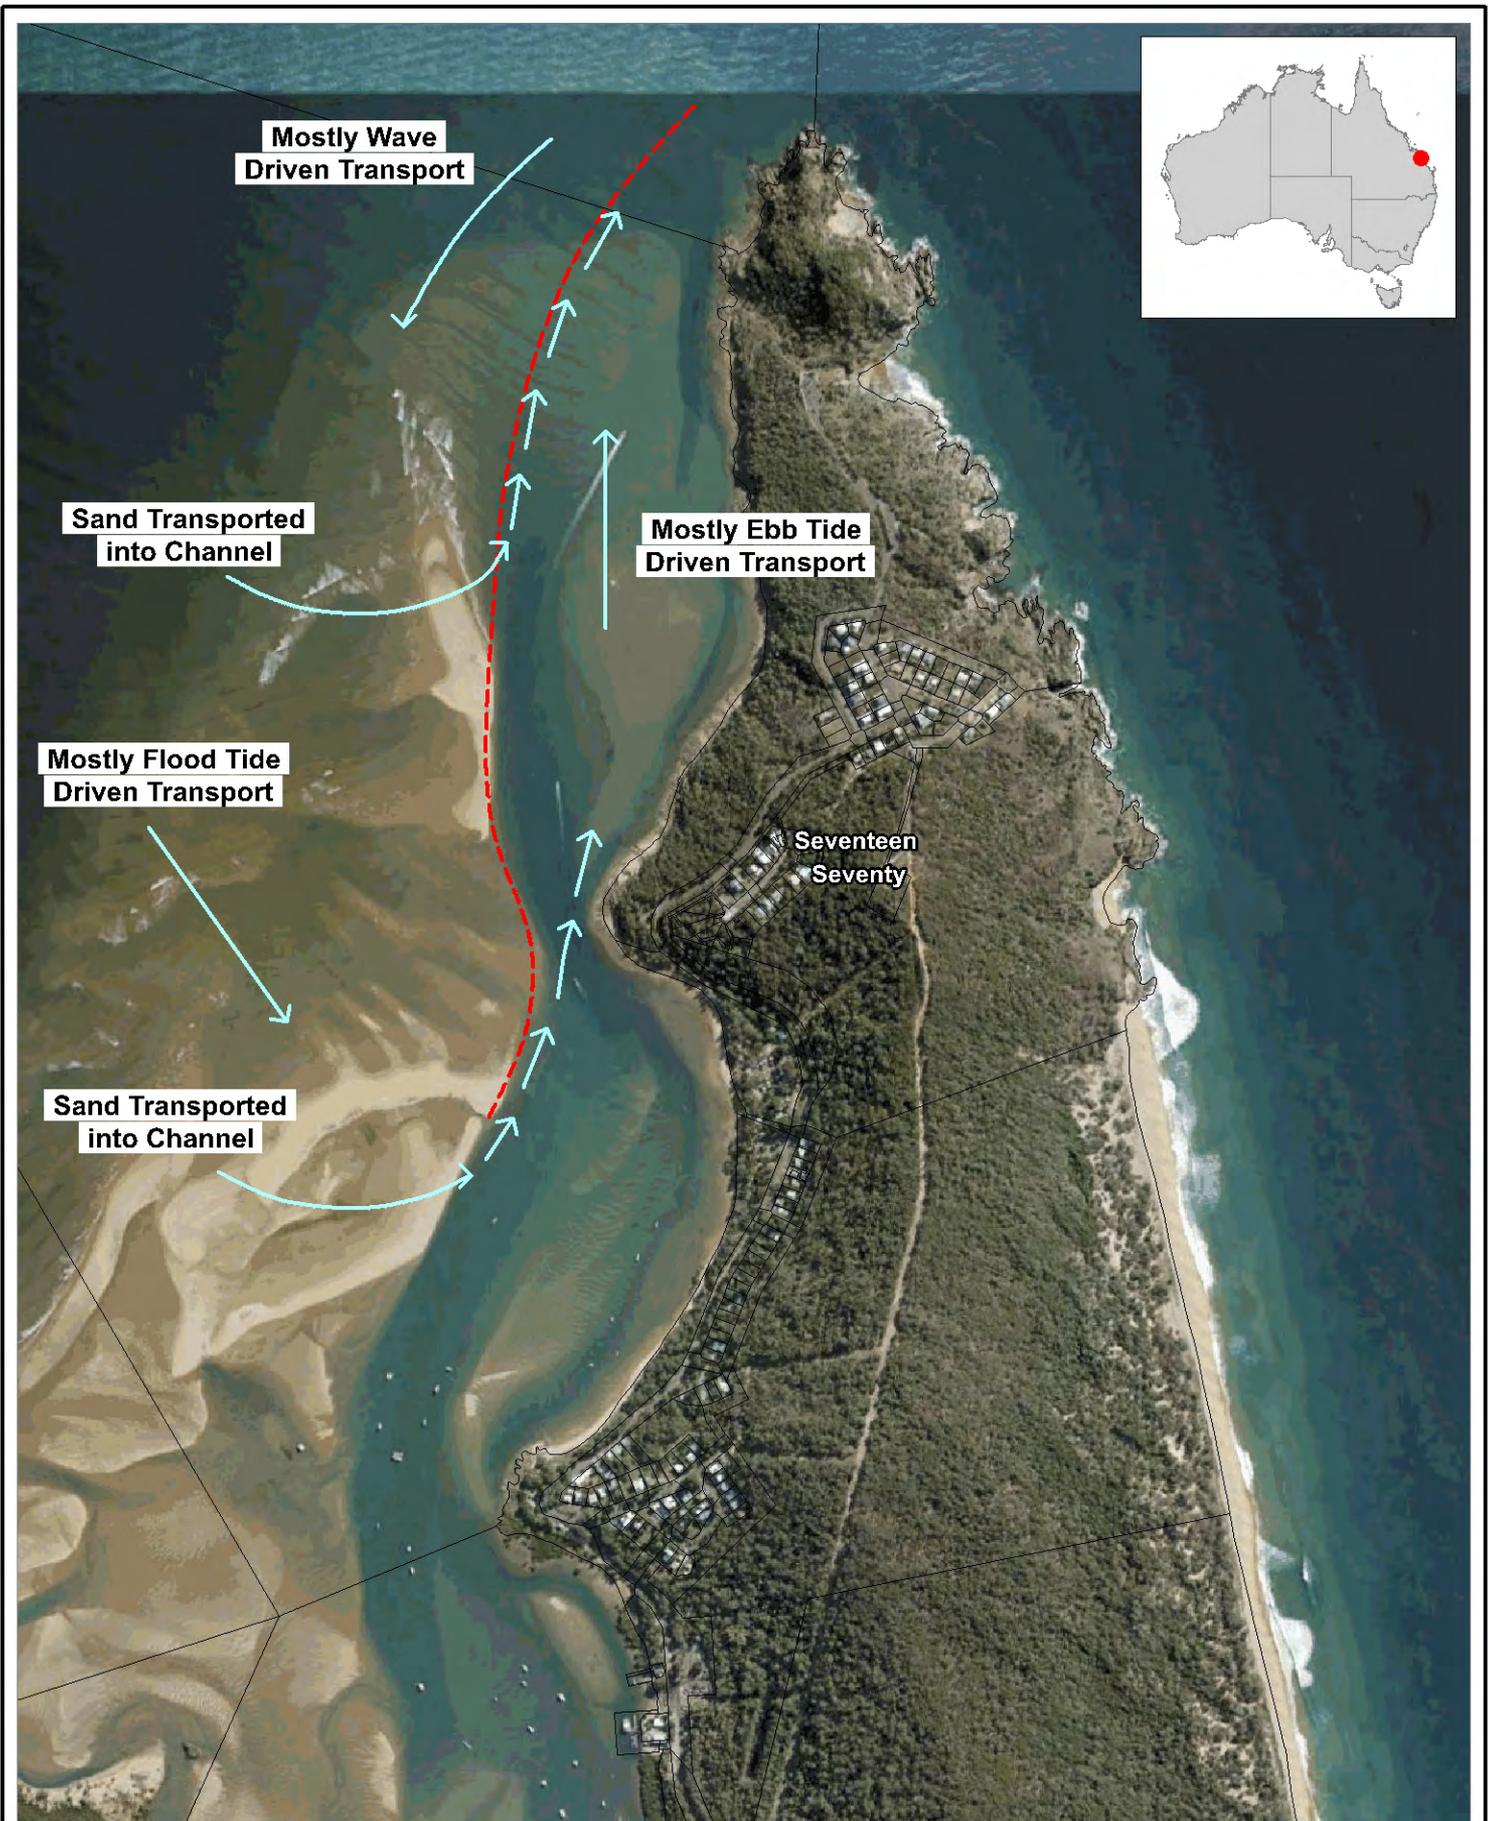
Figure:
3-10

Title:
General Sand Transport Pathways

The conceptual sand movements in the lower estuary are represented in Figure 3-10 which has been updated to include the likely sand transport mechanisms which are continuing to move sand into the lower estuary sand shoals. The behaviour of the channels and shoals is a complex interaction of the prevailing processes as described above. These are subject to natural variability related primarily to meteorological conditions. The dynamic and highly mobile nature of sand movement in the entrance is also evidenced by large bed forms, strong currents and turbulent boils of suspended sediment observed in the water during the site inspection. Consideration of options to maintain a navigable entrance needs to recognise the highly mobile and variable nature of the processes as well as the fact that changes can occur rapidly (in a matter of hours or days) in extreme events as well as gradually through seasonal and longer-term trends. The nature, timing and extent of future behaviour cannot be readily predicted.

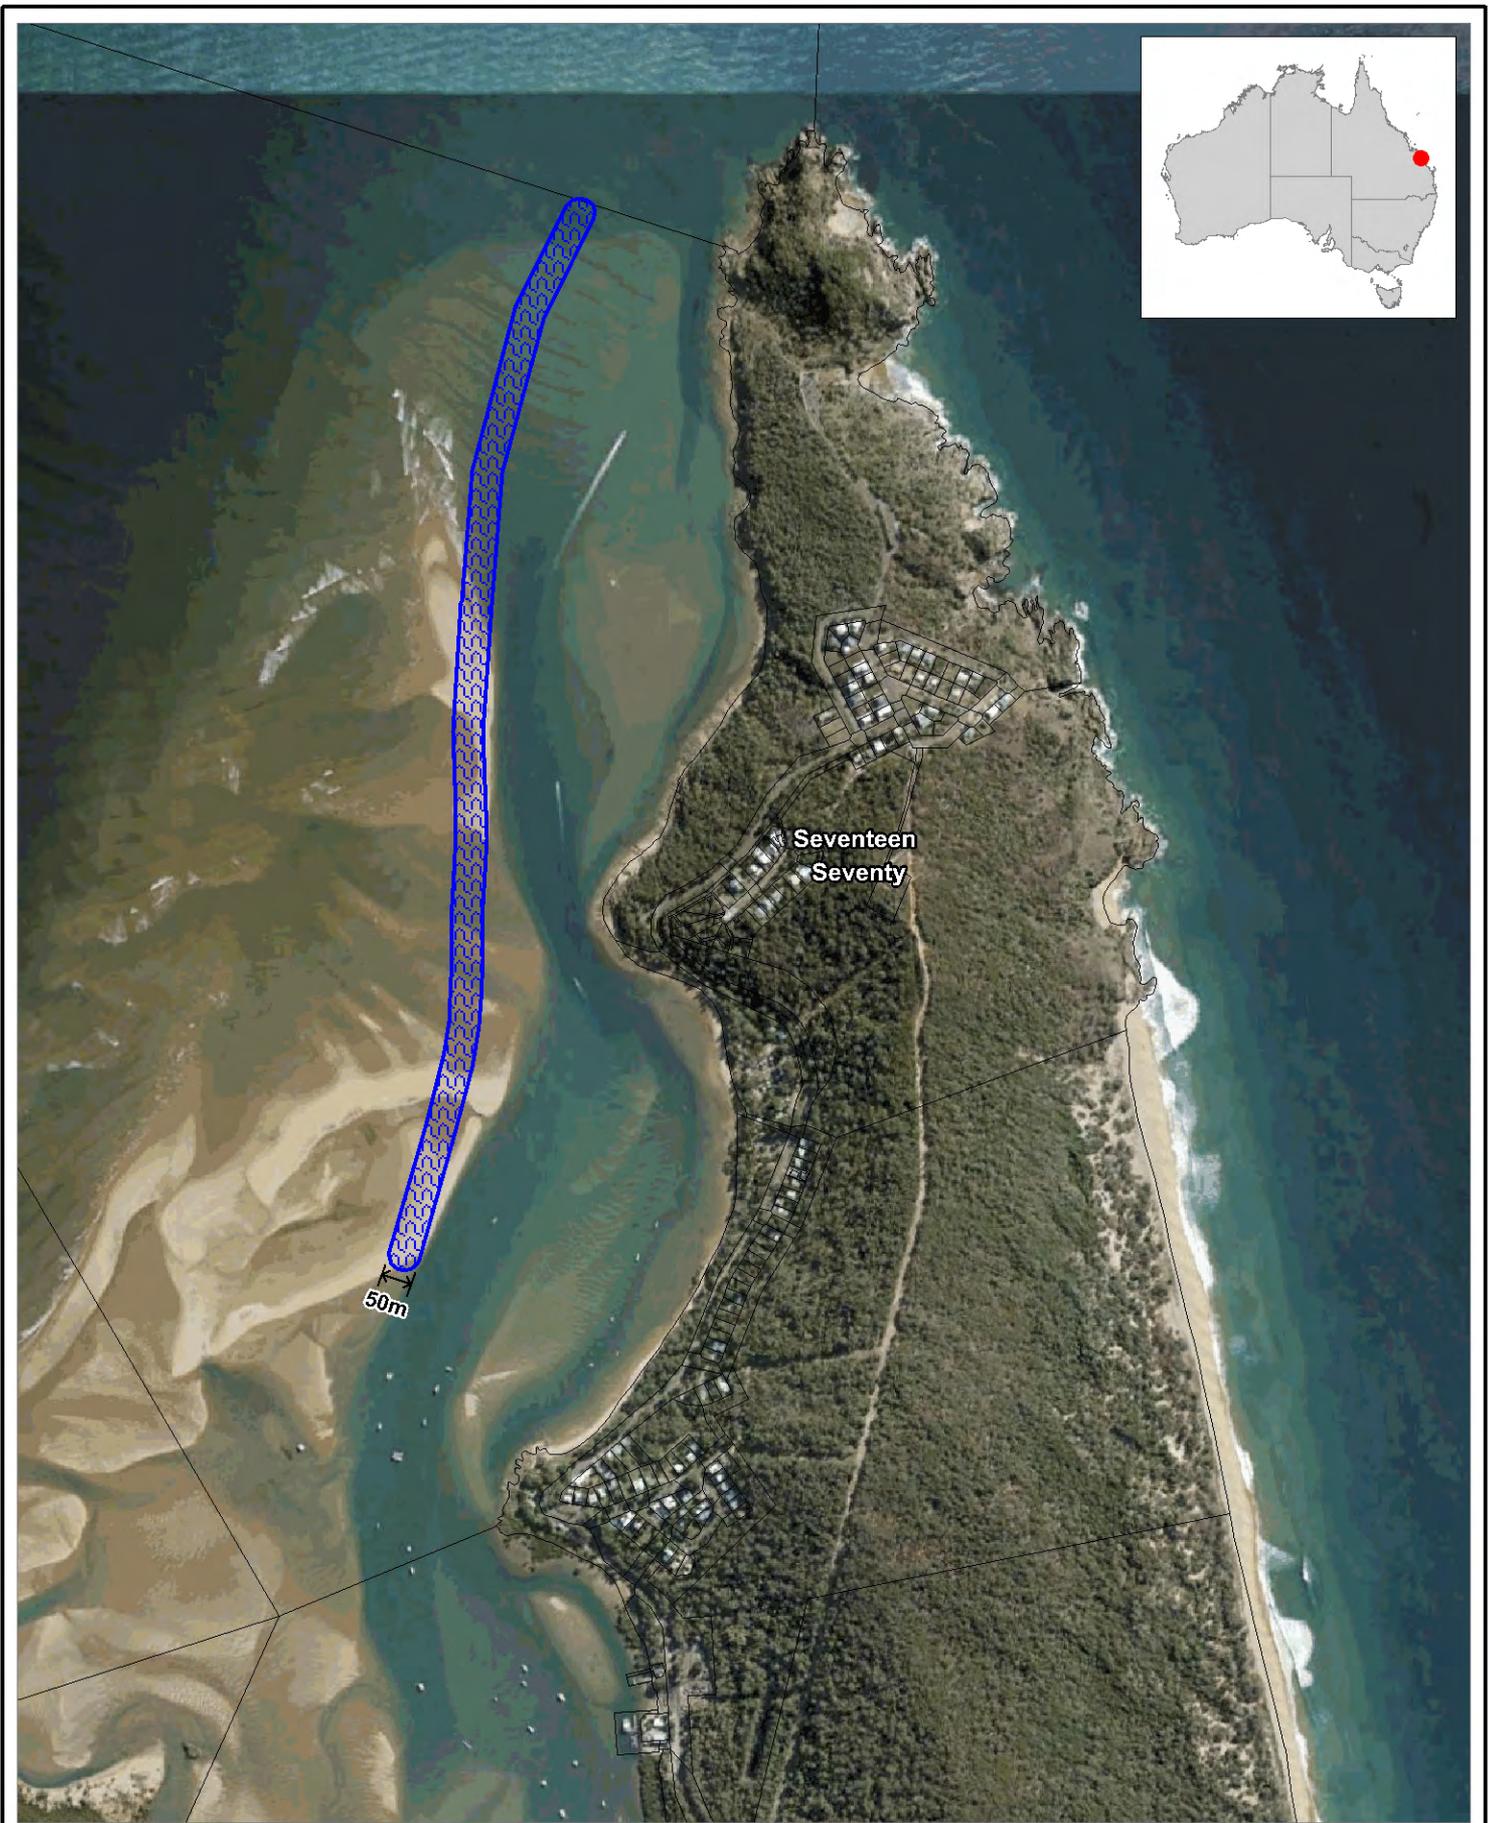
Figure:
4-1

Title:
Possible Training Wall Location

While a training wall as indicated above may maintain a suitable navigable depth within the confines of the channel, sand being transported around Round Hill Head may still enter the channel and/or lead to the formation of a shallow ebb tide delta or shoal beyond the end of the channel with associated navigation constraints. A permanent sand bypassing system would be an option to prevent such build-up of sand or even in its own right to help maintain a navigable channel. Any sand bypassing system (pump and pipeline) would need to be constructed on the headland so that sand can be captured to the east of the channel (possibly to the east of the headland) and deposited to the west of the training wall. Generally, this is usually achieved by sand pumps which collect the sand and pump it under the entrance as a slurry using a pipeline buried under the channel. Figure 4-2 shows the jetty and pumps at the Tweed River required to capture the sand before bypassing.

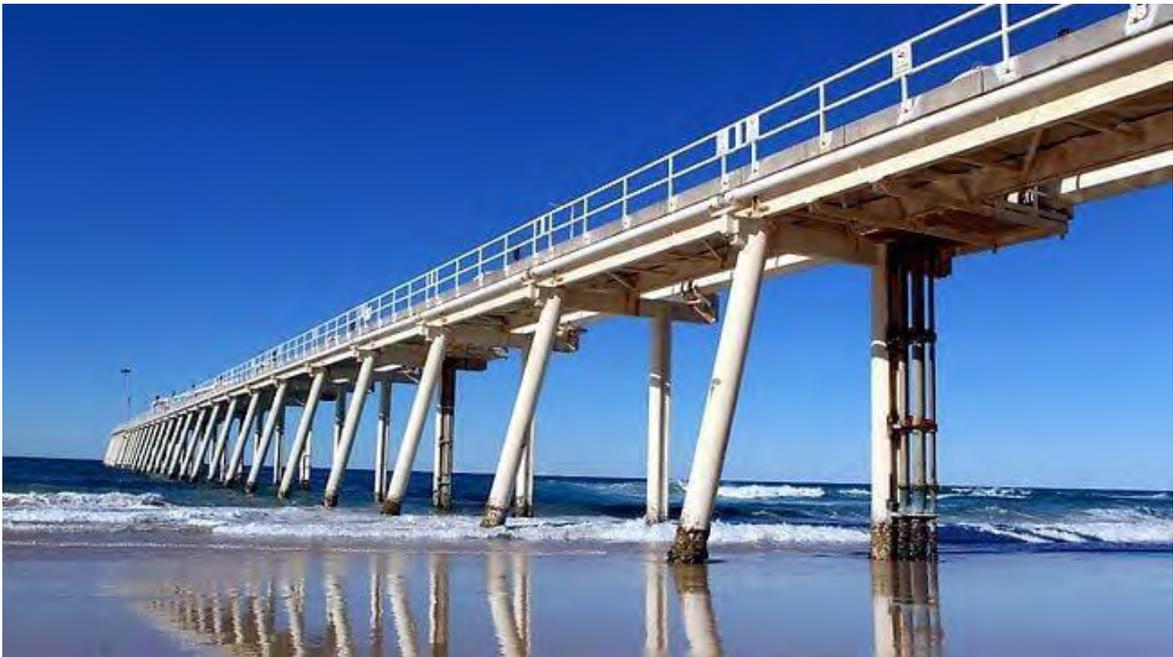
Figure 4-2 Tweed River Sand Bypassing Jetty

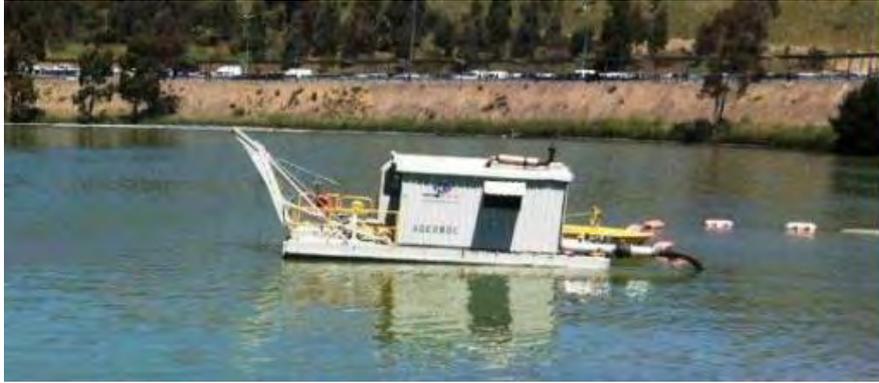
Figure 4-3 Typical Small Dredge
