Round Hill Creek Channel Options

Reference: R.B23355.001.01.docx

Date: January 2019

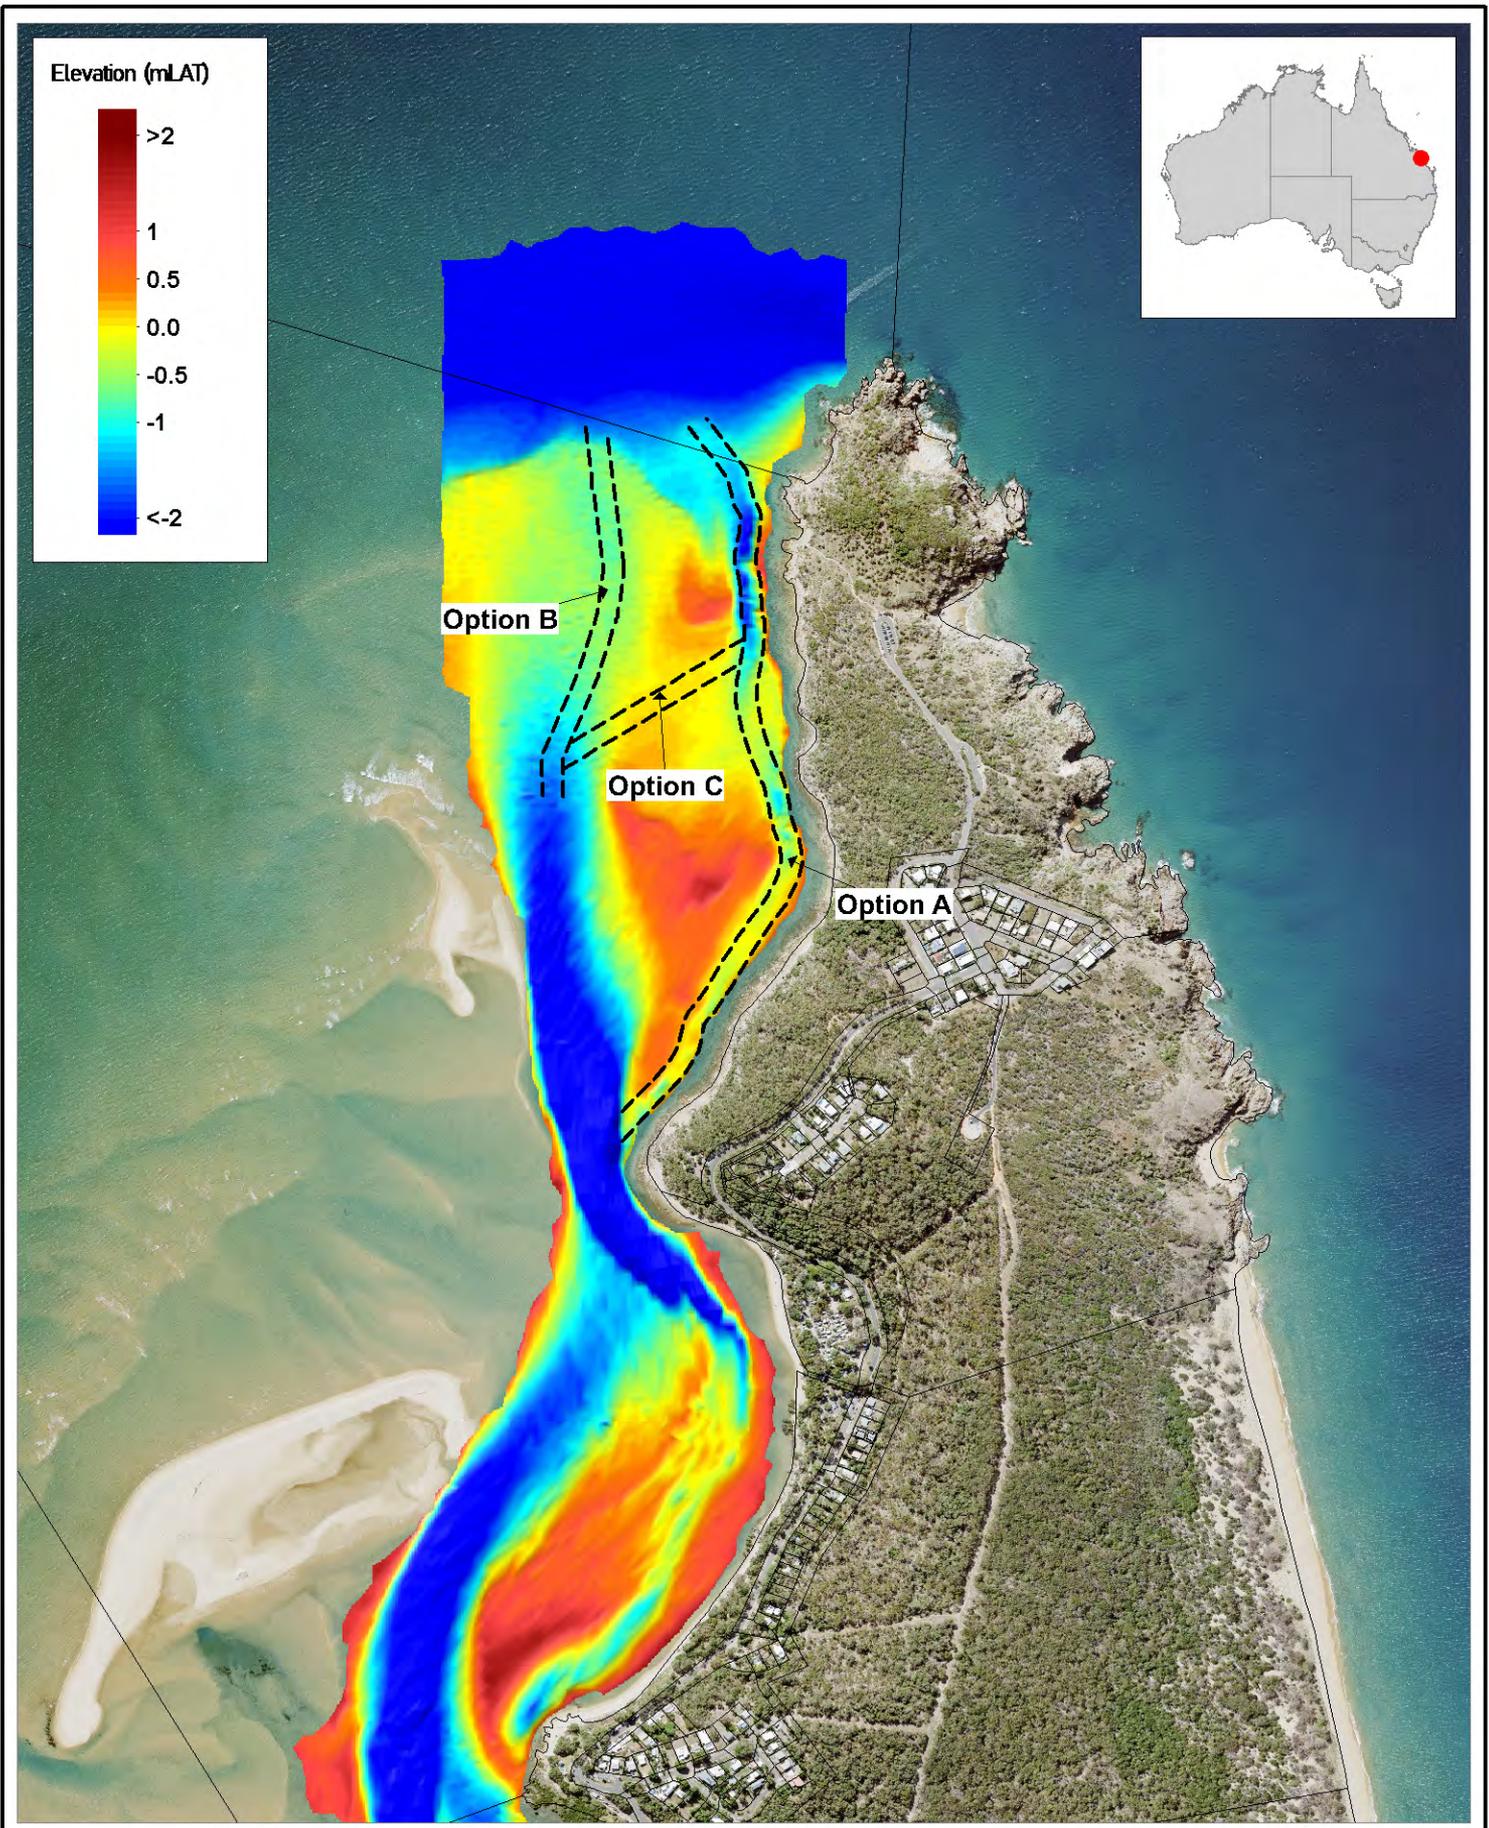
Figure:
4-4

Title:
Dredge Options
(14 September 2018 Survey Data)

- A channel continuing the existing central channel which has been developing in recent years (refer Option B Figure 4-4). There appears to be no constraints e.g. rocks, to dredging this channel and it is likely that wave conditions will be favourable for dredging via conventional means much of the time exclusive of cyclones. While this alignment would be working with the present trend of the developing channel, historical aerial photography for the last 60 years does not indicate that this is one of the broadly consistent channel alignments over time. The highly mobile nature of the sediments in this area as evidenced by wave action along the outer edge of the delta and strong currents indicates that rapid infill is likely. It is therefore expected that significant annual maintenance will still be required to maintain a channel along this alignment. Waves breaking across the outer edge of the channel will also be a navigation constraint for smaller vessels.

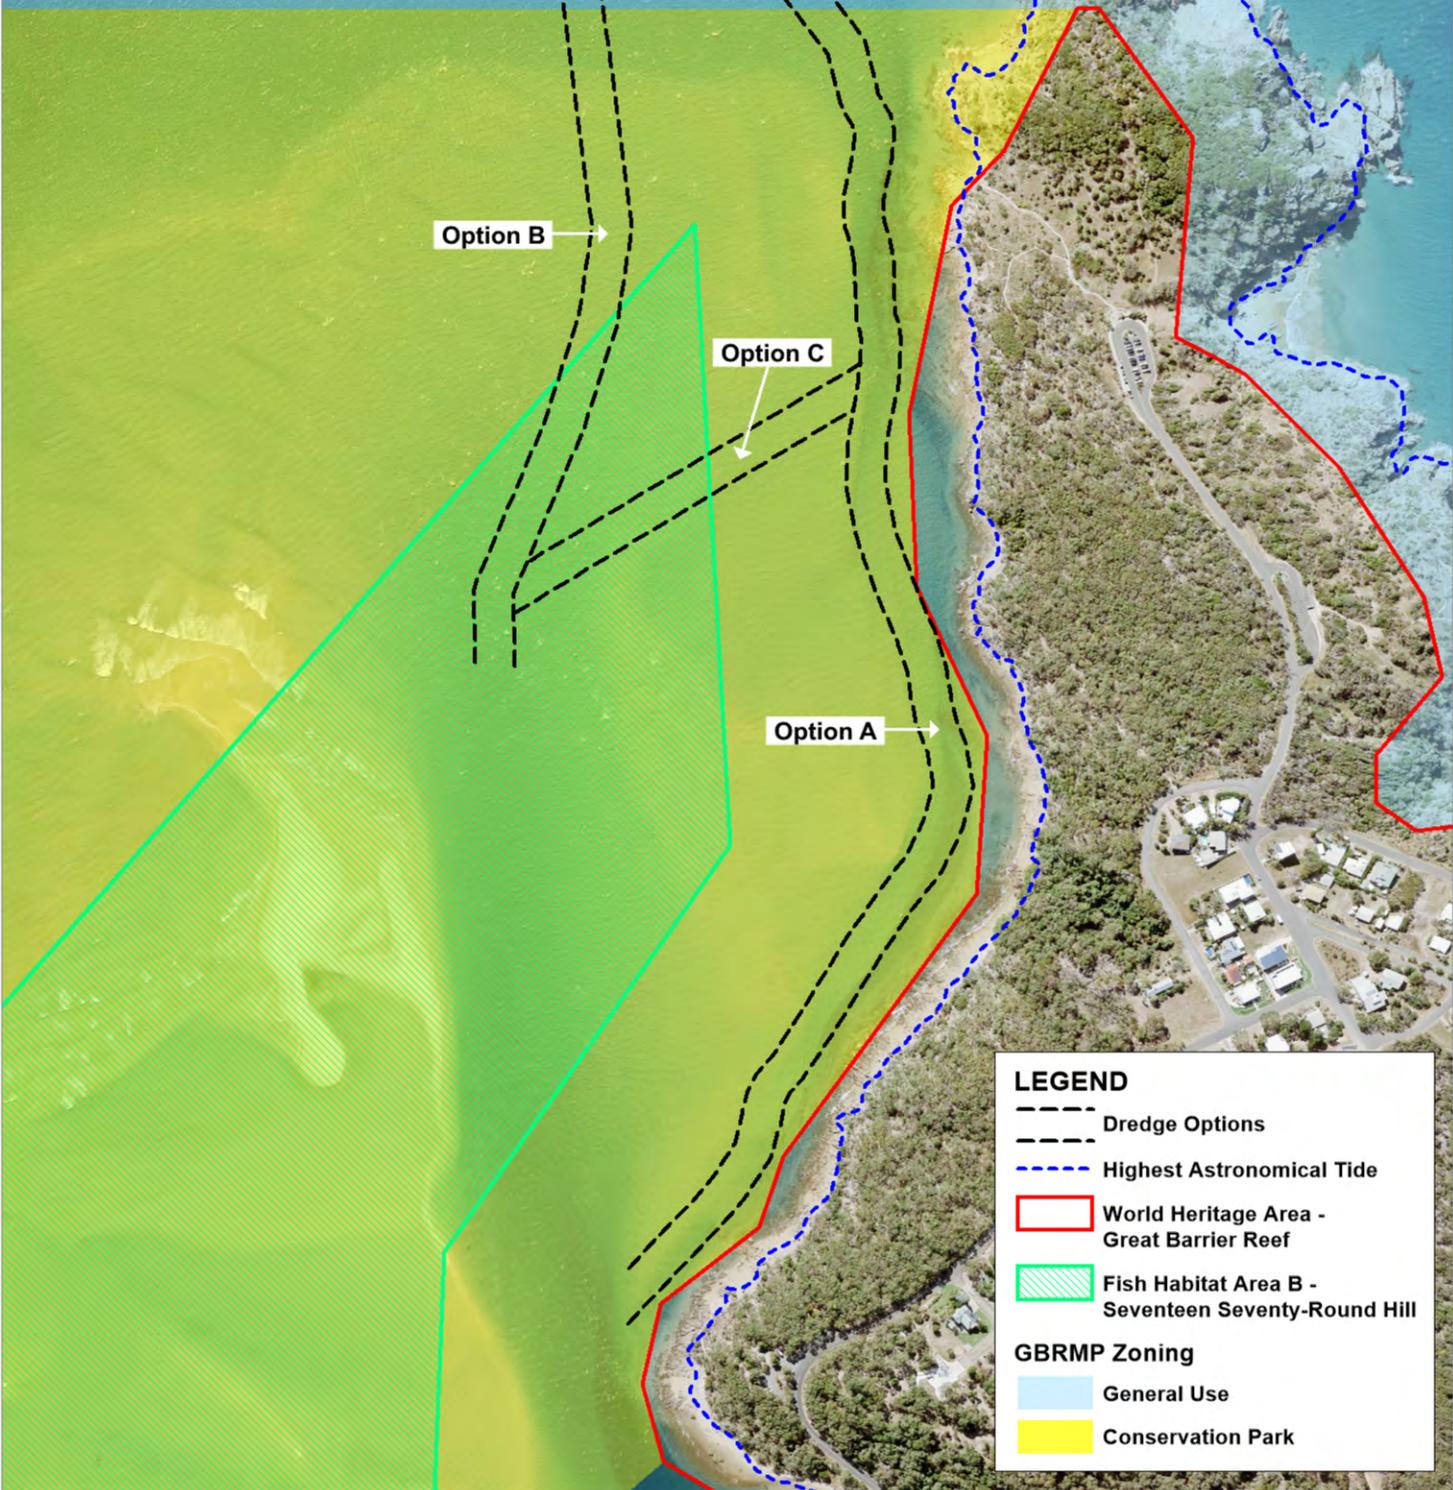
Figure 5-1 shows the three potential dredging options comparative to the location of the GBRWHA, GBRMP, GBR Coast MP, and FHA.
