FINAL REPORT:

Agnes Water and Seventeen Seventy Shoreline Erosion Management Plan (SEMP)

April 2020

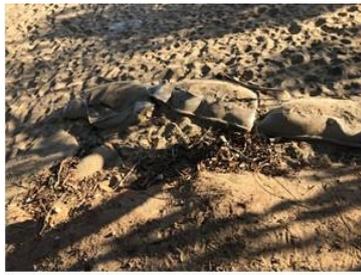
Geobags to protect the erosion scarp

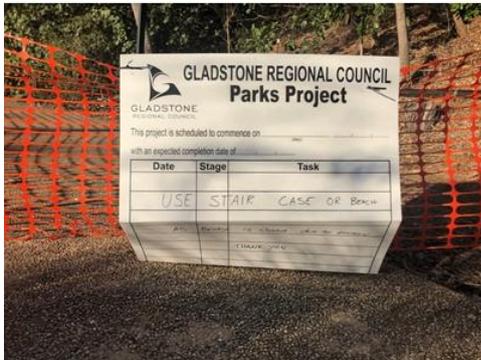
Fencing to deter access to damaged path and boardwalk
